# **Sewerage & Water Board OF NEW ORLEANS**

Re: Sewerage and Water Board of New Orleans Modified Consent Decree – Civil Action No. 93-3212  
Paragraph 43: Force Main Reliability Evaluation & Findings

## New Orleans, Louisiana

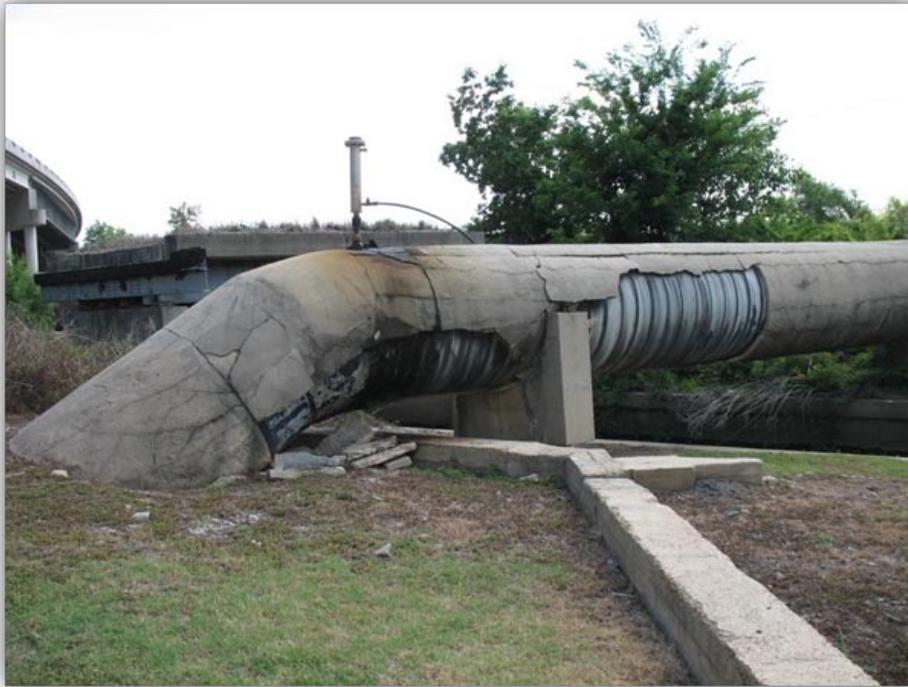
Deterioration of cement mortar coatings was noted in the above ground locations. The location of cement mortar deterioration was on the upstream side of the 60-inch crossing at the Peoples Avenue Canal. As shown in **Photograph 4.1** on the following page, the cement mortar coating is broken and displaced. The damage was repaired by the Board as part of restoring the pipe after coupon removal. **Photograph 4.2** shows the repaired cement mortar coating of the 60-inch crossing at Peoples Avenue Canal. Two “wet areas” were observed along the SFM alignments. One of the wet areas with ponded water was determined to be a water main leak. Another wet area was noted near where the 72-inch SFM crosses the 54-inch SFM. This leak was on the 4-inch discharge pipe for the manual air release valve and not on the SFM pipe wall. This leak was repaired. Four surface depressions or “sink holes” were noted along the SFM alignments as shown in **Photographs 4.3** through **4.6**. None of these depressions exhibited running water and each is being investigated further by the Board to better understand the cause. Maintenance issues such as displaced frames and covers on access manholes as shown in **Photograph 4.7** and the potentially buried access manhole in **Photograph 4.8** were also noted.

**Photograph 4.1**  
**Peoples Avenue Canal Crossing Coating Deterioration**

Some maintenance issues were noted. In particular, deterioration of cement mortar coatings in several locations. The coating deterioration was most notable on the 60-inch pipe crossing the Peoples Avenue Canal. As a result of this inspection the cement mortar coating at the Peoples Avenue Canal was repaired and a new air release valve installed.

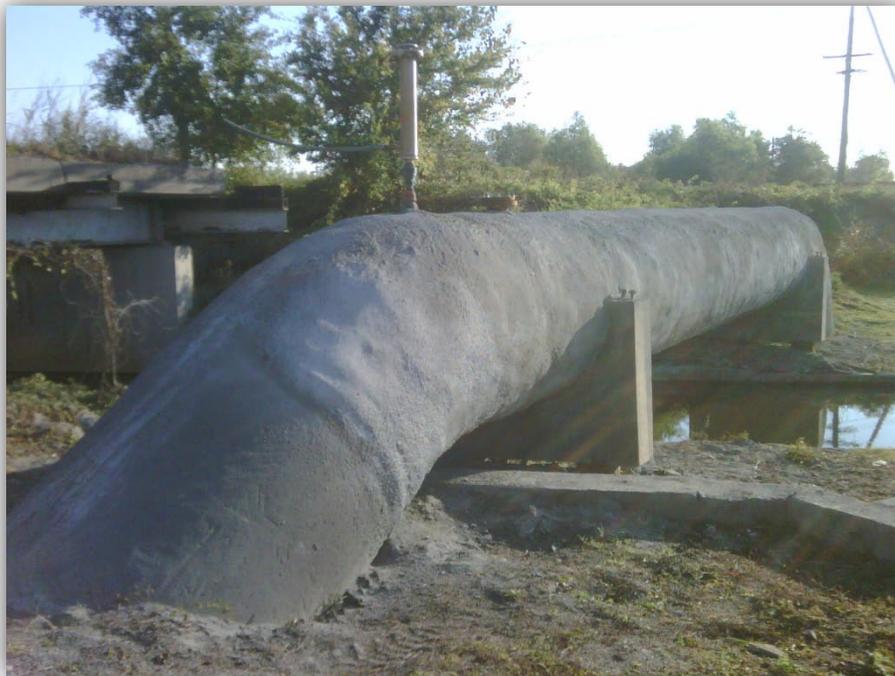
**Photograph 4.2**  
**Peoples Avenue Canal Crossing Repaired**

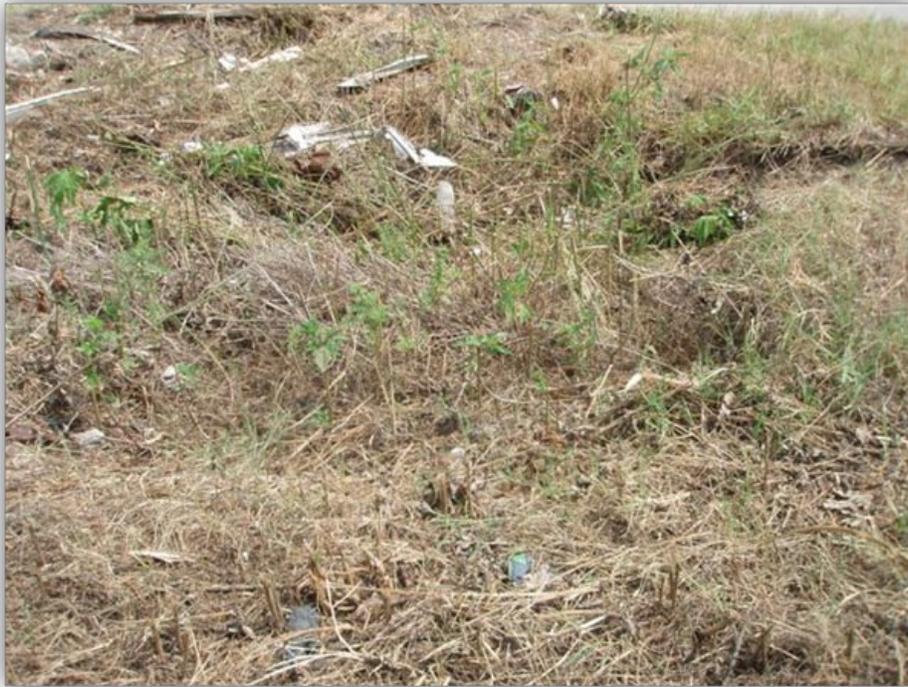
**Photograph 4.3**  
**Soil Subsidence Near 54-Inch SFM Along Florida Avenue Near Reynes Street**

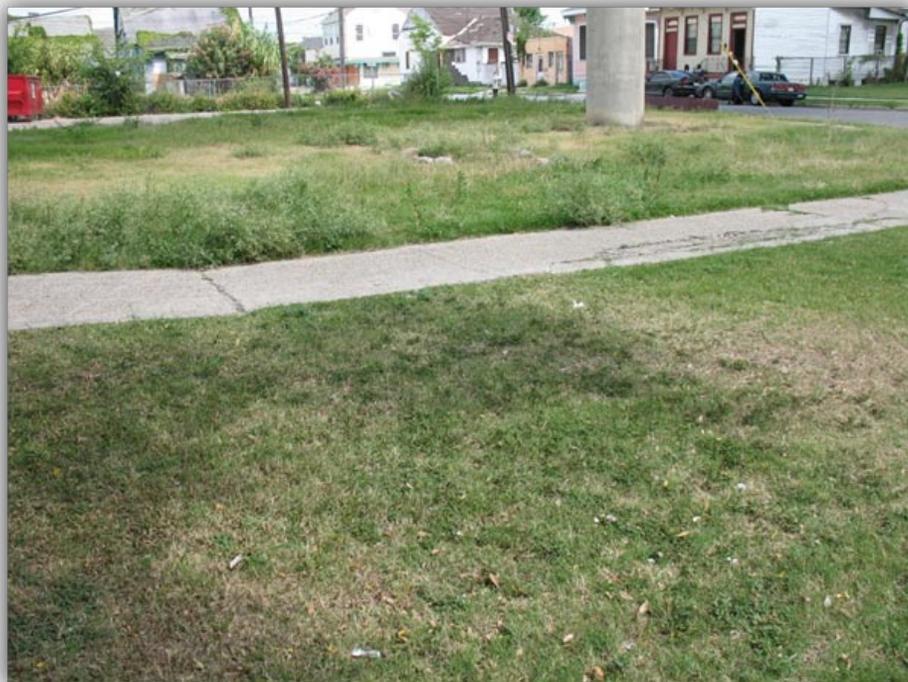
**Photograph 4.4**  
**Soil Subsidence Near 72-Inch SFM Across From 3211½ Shell Street**

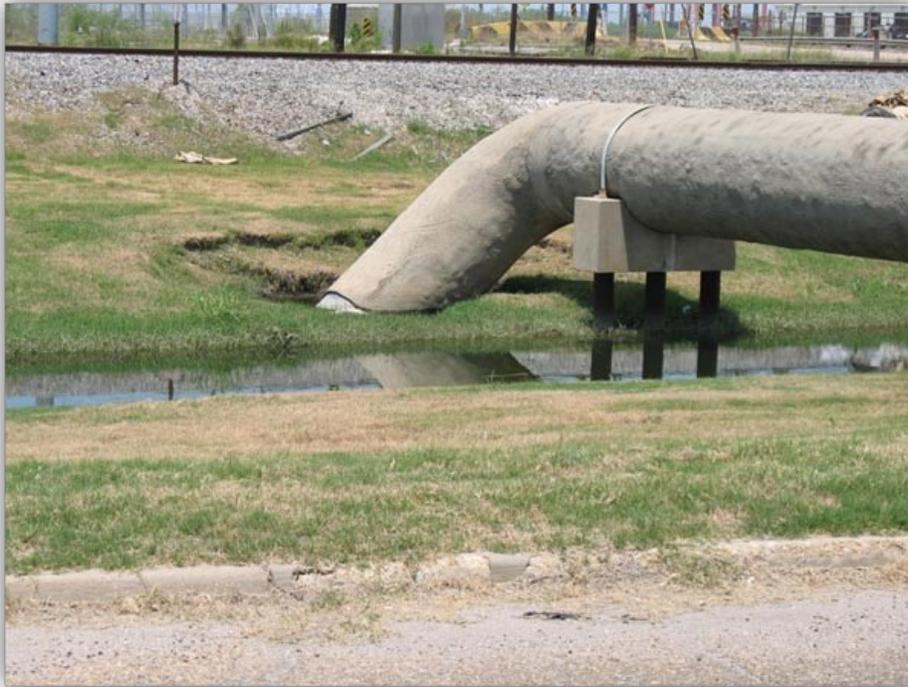
**Photograph 4.5  
Soil Subsidence Near 54-Inch SFM**

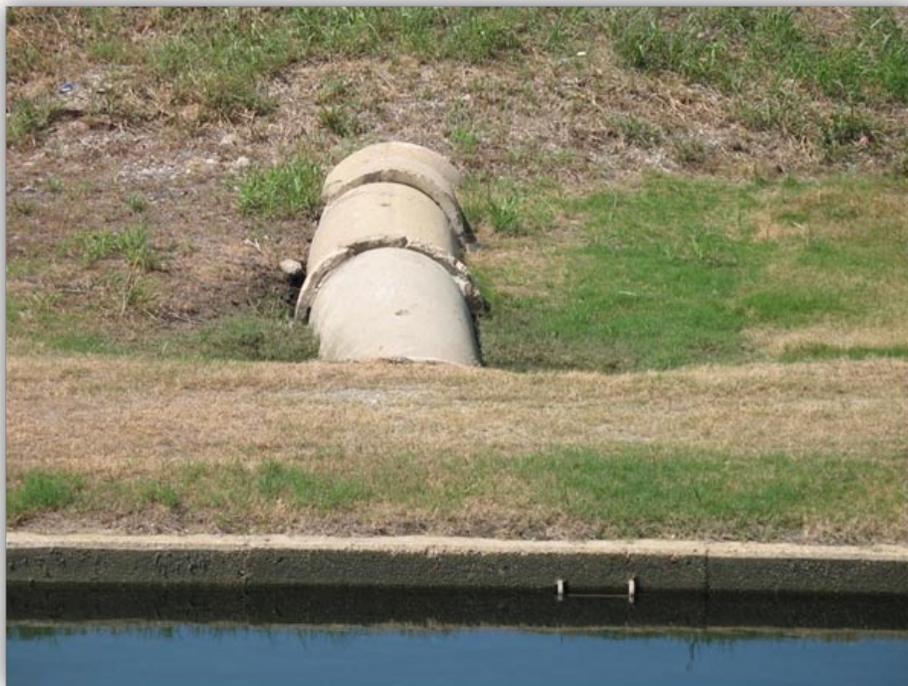
**Photograph 4.6  
Soil Subsidence Near 60-Inch SFM Crossing Under Storm Sewer (Shown)**

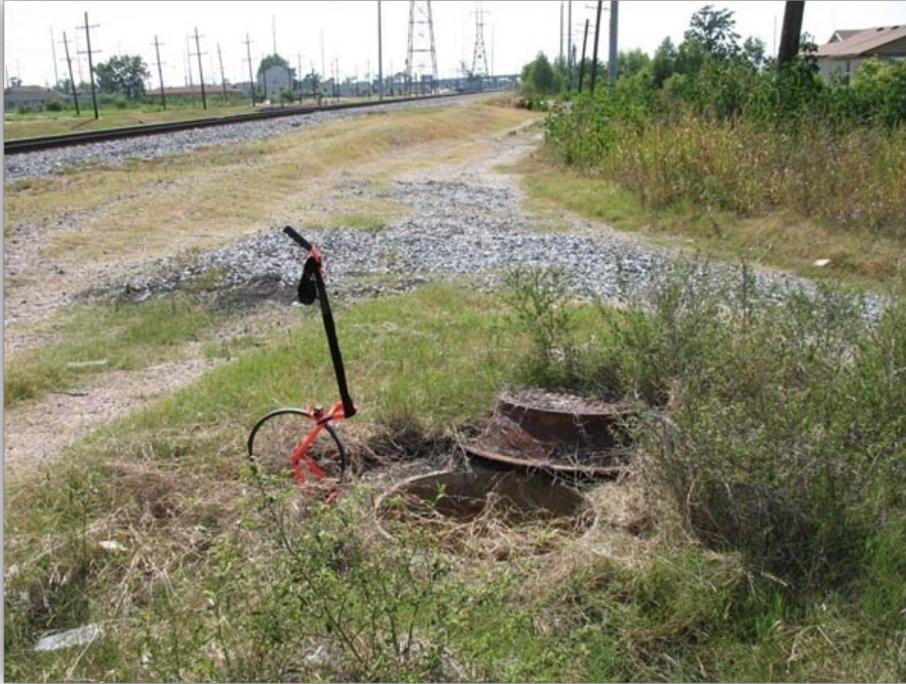
**Photograph 4.7**  
**Access MH on 72-Inch SFM**

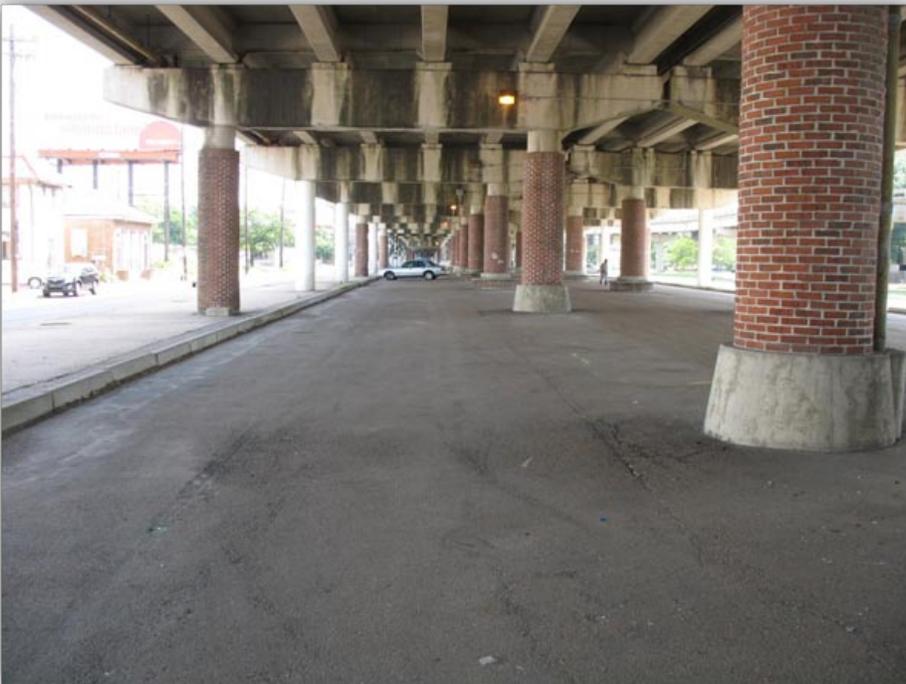
**Photograph 4.8**  
**Not Found Access MH on 72-Inch SFM**

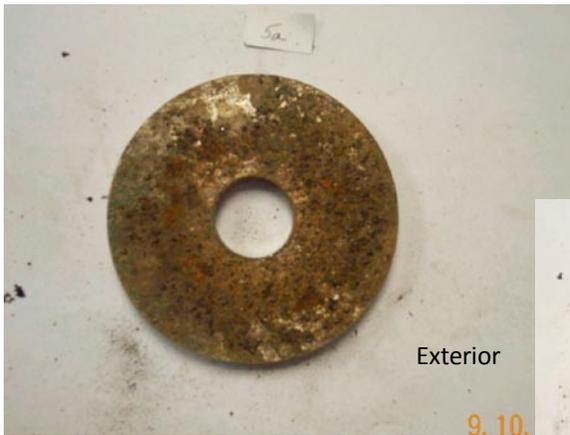
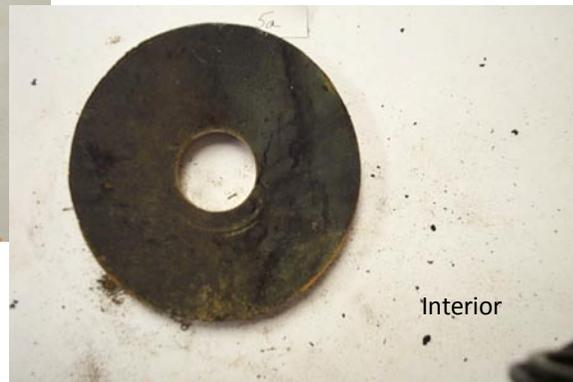
### Location 5A Peoples Avenue near SPS D

No corrosion

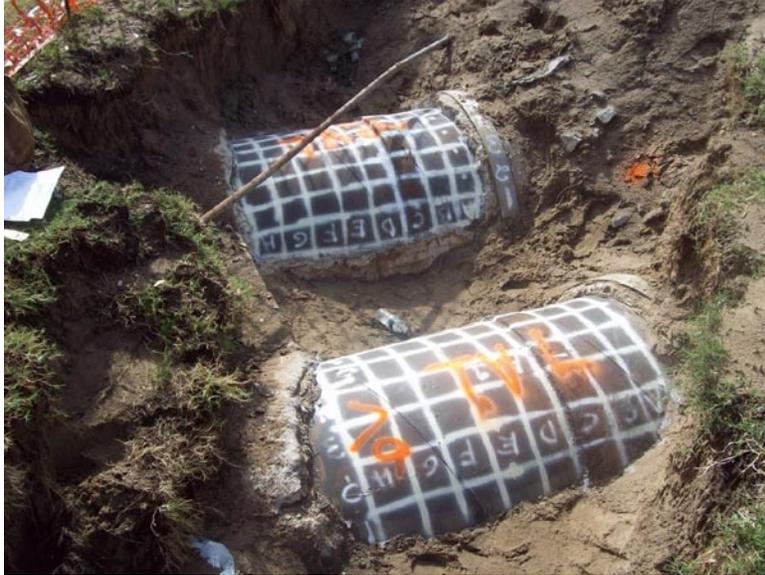
### **Location 7A St. Bernard Avenue Box Culvert Crossing**

Non Destructive Ultrasonic Testing (below grade) two 48-inch SFMs crossing the box culvert in the median. The SFMs are only 1 foot below grade and are cut into the top of the box culvert.

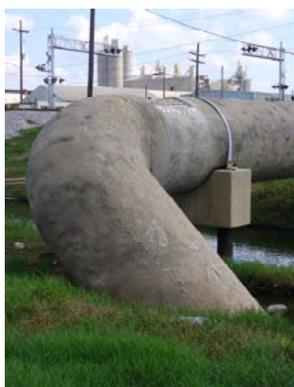
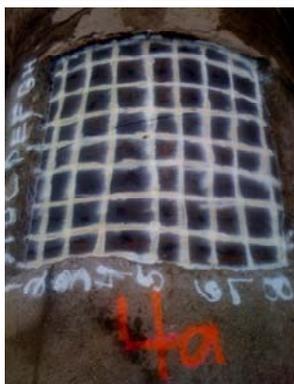
Following the removal of the gunite, the coating appears to be in moderate condition. The coating has very little to no adhesion properties. It appears the coating has reached its life expectancy and is in the process of breaking down. During the visual inspection only minor surface corrosion was present.

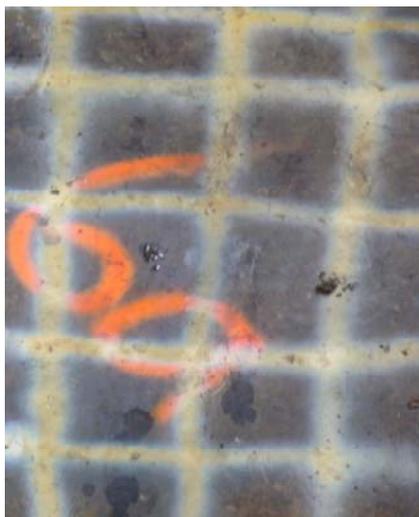
Following the removal of the gunite, the abatement crew removed all the coating prior to the visual inspection being conducted. Surface are had minor surface corrosion present.

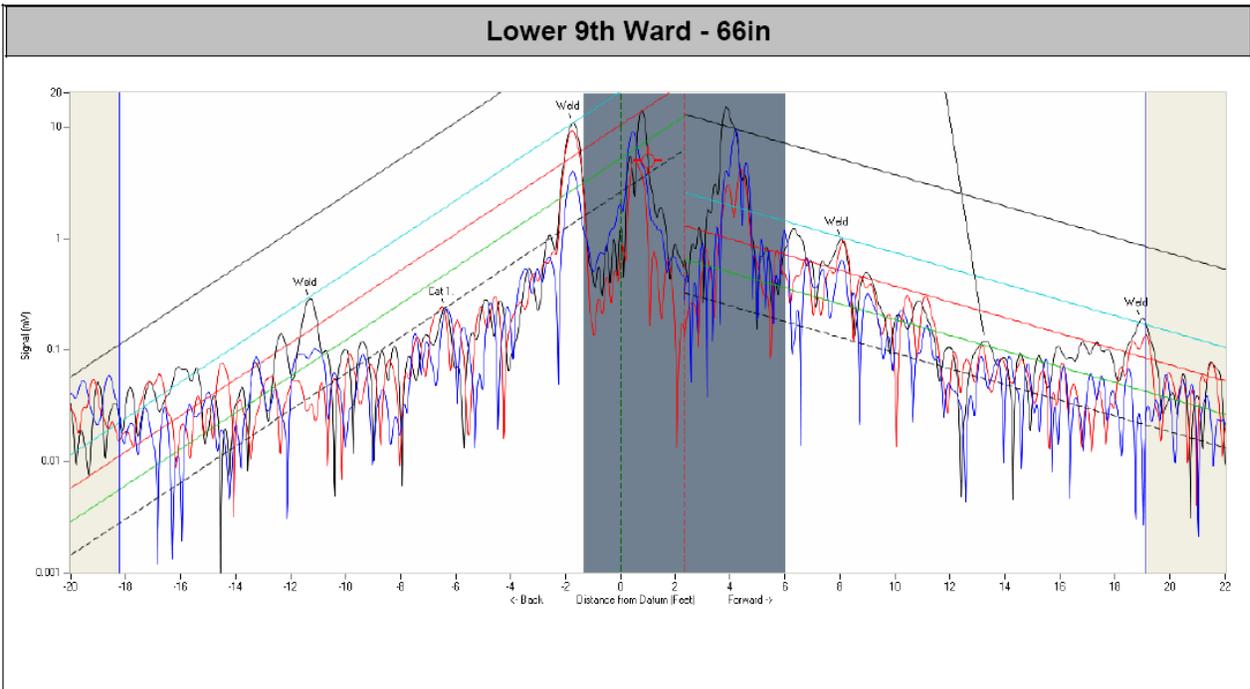
Distance relative to datum	Indication Description	Comments	Priority
-10.61ft	Weld		
-5.70ft	Cat 1.		Low
-1.03ft	Weld		
7.29ft	Weld		
12.52ft	See info	Strong axisymmetric Cat. 1 amplitude response. Could be from a weld or a reverberation.	
18.20ft	Weld

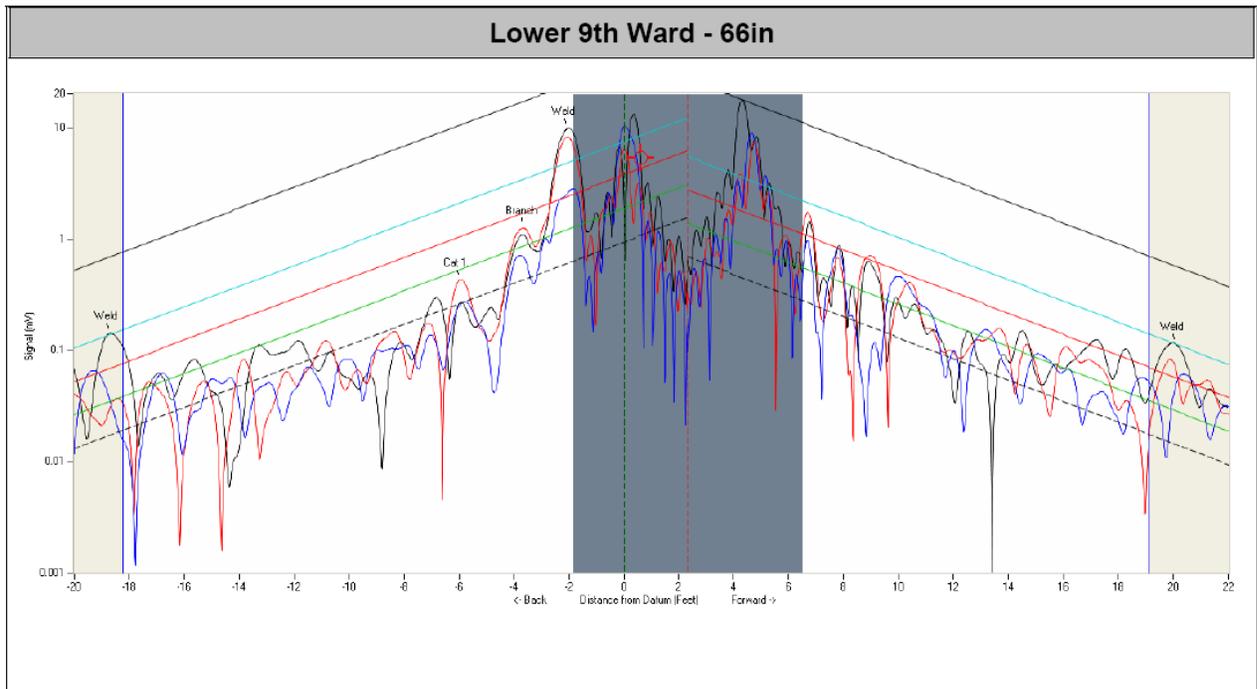
Distance relative to datum	Indication Description	Comments	Priority
-17.72ft	Weld		
-5.02ft	Cat 1.		Low
-2.75ft	Branch		
-1.08ft	Weld		
19.13ft	Weld

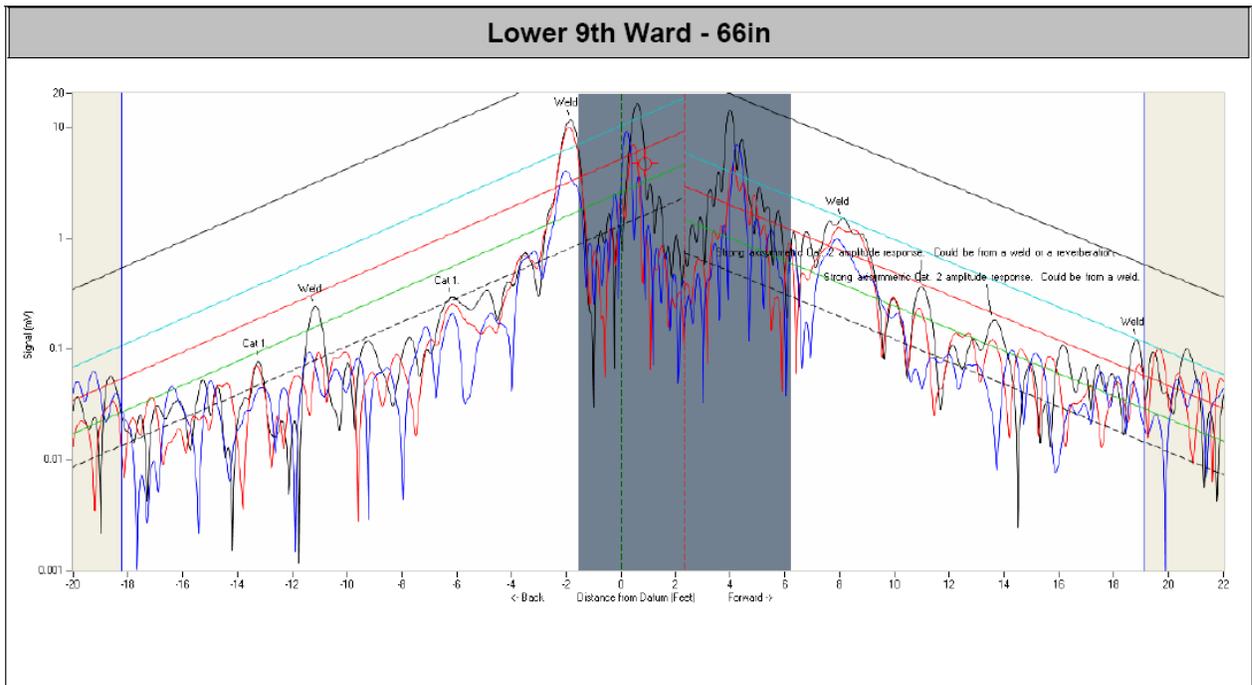
Distance relative to datum	Indication Description	Comments	Priority
-12.41ft	Cat 1.		Low
-10.35ft	Weld		
-5.41ft	Cat 1.		Low
-1.04ft	Weld		
7.24ft	Weld		
10.11ft	See info	Strong axisymmetric Cat. 2 amplitude response. Could be from a weld or a reverberation.	
12.74ft	See info	Strong axisymmetric Cat. 2 amplitude response. Could be from a weld.	
18.00ft	Weld

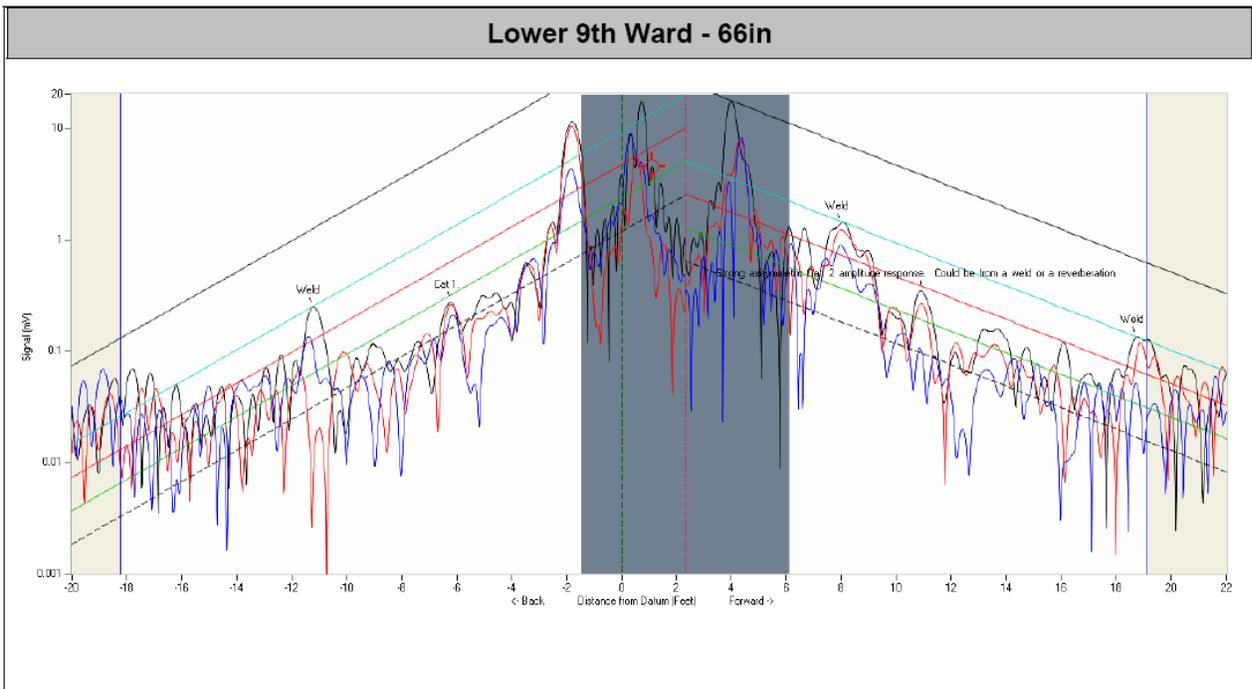
Distance relative to datum	Indication Description	Comments	Priority
-10.47ft	Weld		
-5.46ft	Cat 1.		Low
7.19ft	Weld		
10.09ft	See info	Strong axisymmetric Cat. 2 amplitude response. Could be from a weld or a reverberation.	
17.94ft	Weld

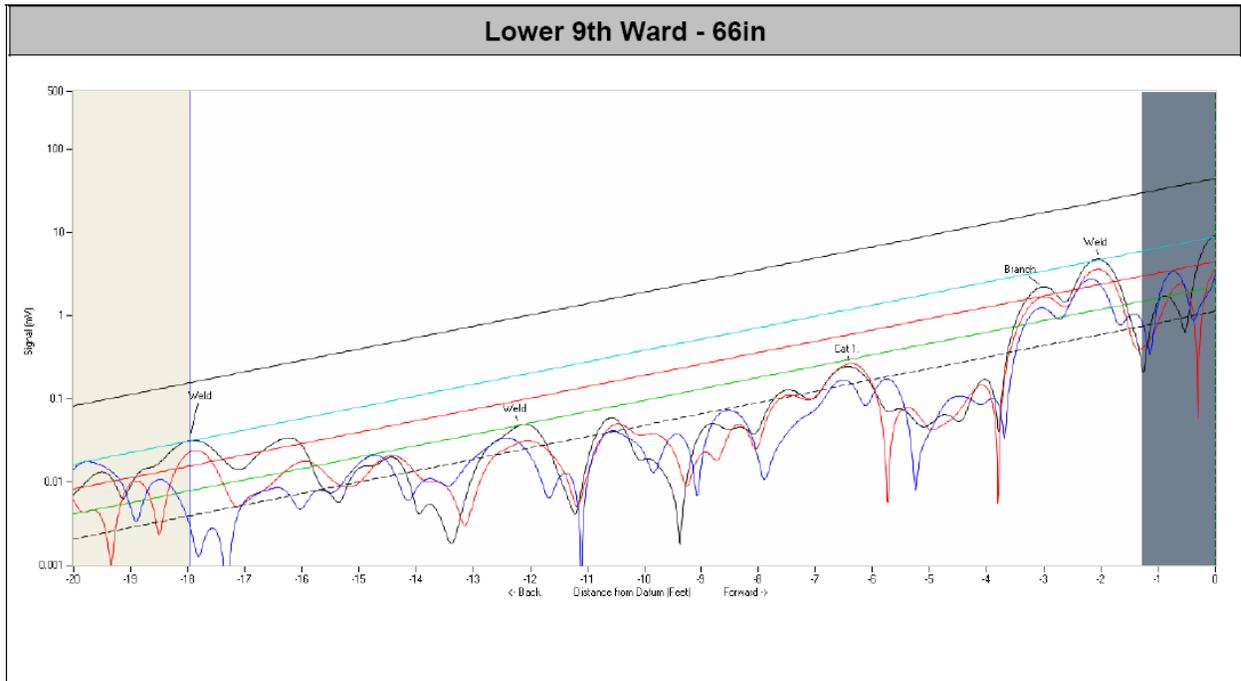
Distance relative to datum	Indication Description	Comments	Priority
-16.98ft	Weld		
-11.21ft	Weld		
-5.42ft	Cat 1.		Low
-2.02ft	Branch		
-1.02ft	Weld

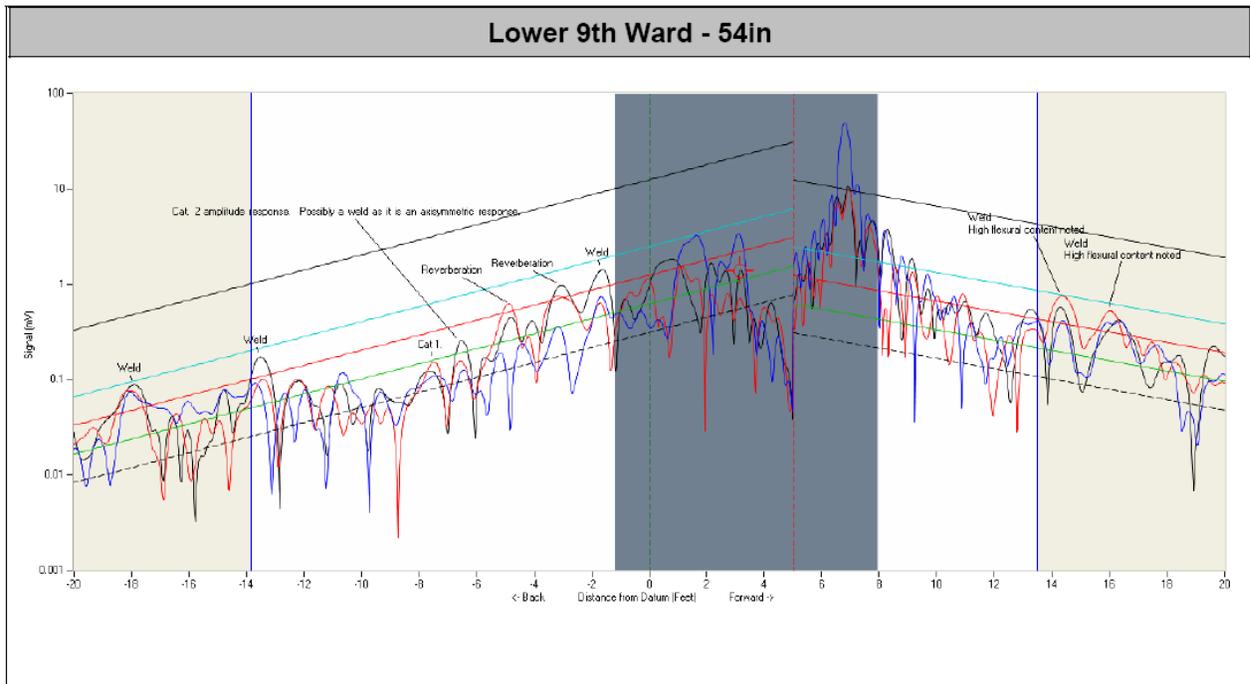
Distance relative to datum	Indication Description	Comments	Priority
-27.21ft	Weld		
-17.13ft	Weld		
-12.75ft	Weld		
-6.70ft	Cat 1.		Low
-5.77ft	See info	Cat. 2 amplitude response. Possibly a weld as it is an axisymmetric response.	
-4.00ft	See info	Reverberation	
-2.25ft	See info	Reverberation	
-0.86ft	Weld		
13.53ft	Weld	High flexural content noted	
15.13ft	Weld	High flexural content noted

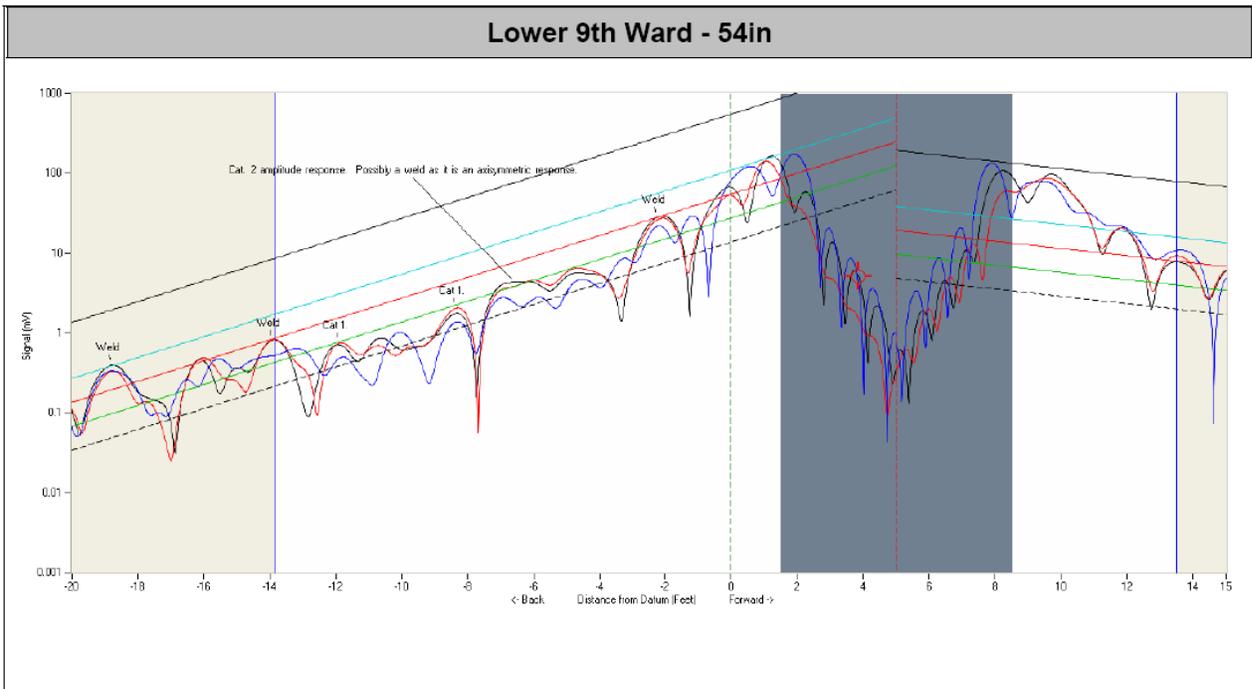
Distance relative to datum	Indication Description	Comments	Priority
-17.44ft	Weld		
-12.57ft	Weld		
-10.57ft	Cat 1.		Low
-7.04ft	Cat 1.		Low
-5.25ft	See info	Cat. 2 amplitude response. Possibly a weld as it is an axisymmetric response.	
-0.90ft	Weld

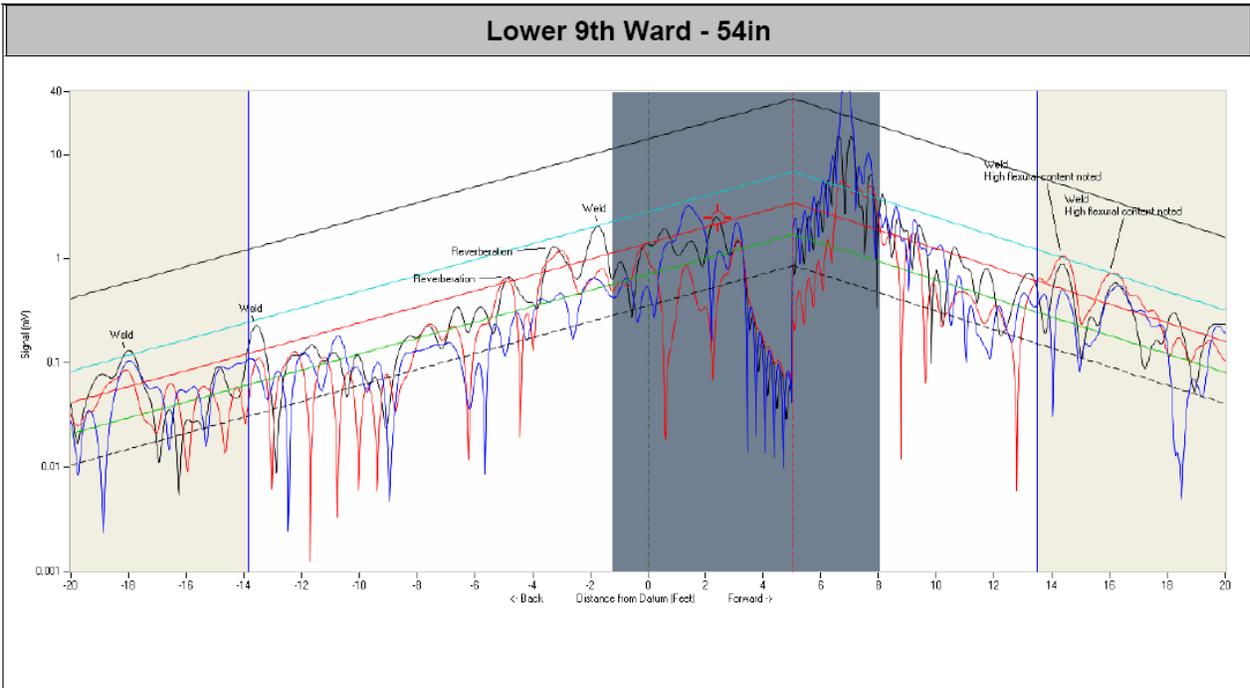
Distance relative to datum	Indication Description	Comments	Priority
-17.25ft	Weld		
-12.78ft	Weld		
-4.00ft	See info	Reverberation	
-2.50ft	See info	Reverberation	
-0.87ft	Weld		
13.49ft	Weld	High flexural content noted	
15.20ft	Weld	High flexural content noted
