# **Sewerage & Water Board OF NEW ORLEANS**

Re: Sewerage and Water Board of New Orleans Modified Consent Decree – Civil Action No. 93-3212  
Paragraph 43: Force Main Reliability Evaluation & Findings

## New Orleans, Louisiana

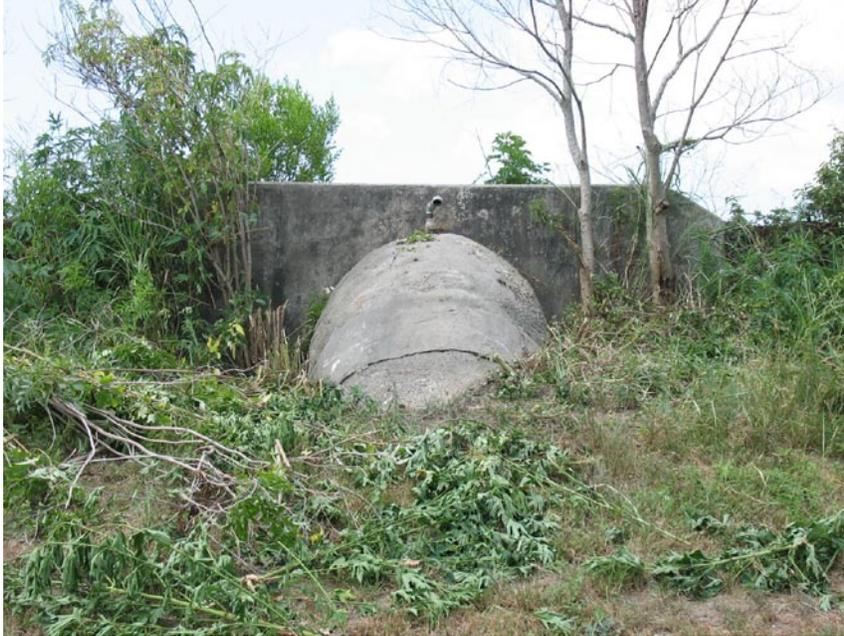
### Location 1A at East Bank WWTP

Non Destructive Ultrasonic Testing (above grade) near EBWWTP 66-inch SFM

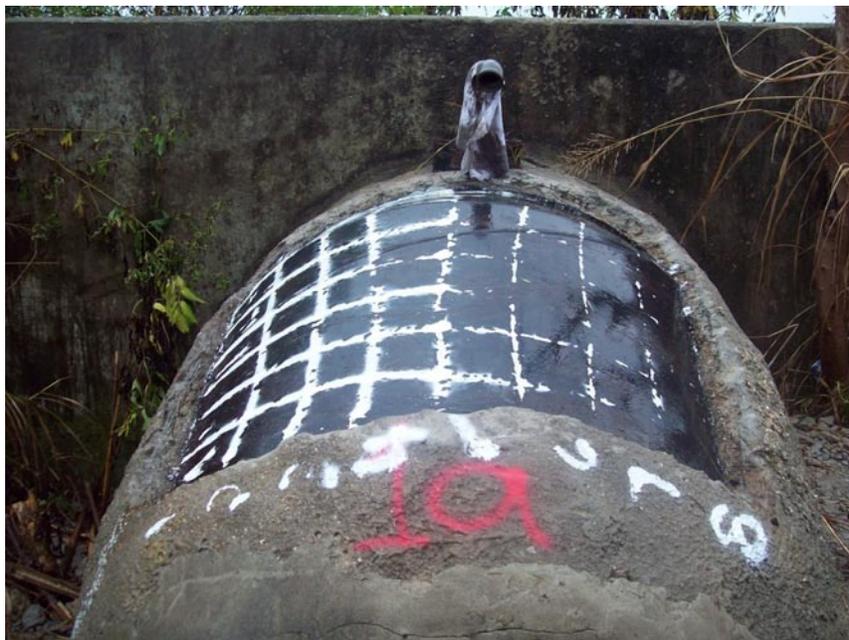
### Location 1A at East Bank WWTP

Non Destructive Ultrasonic Testing (above grade) near EBWWTP 66-inch SFM

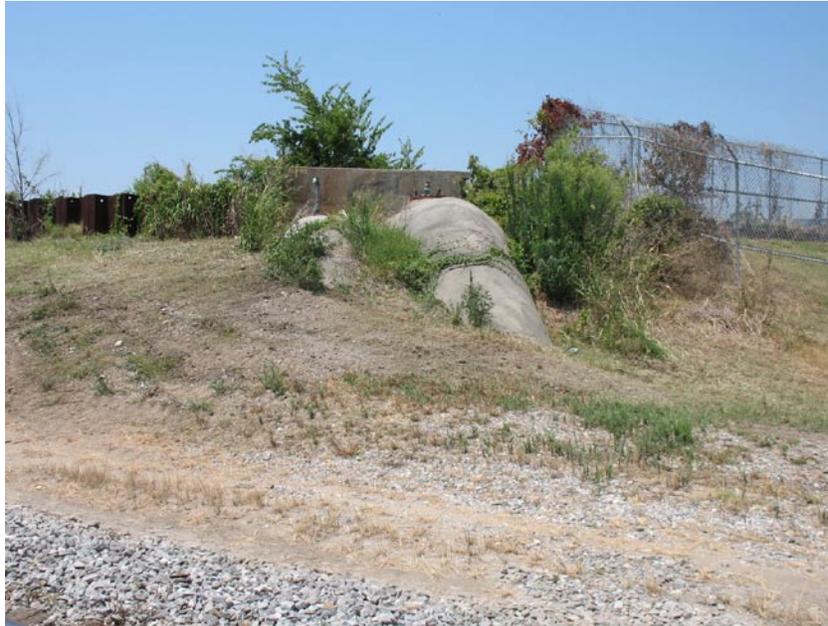
**Location 1B at East Bank WWTP**

Non Destructive Ultrasonic Testing (above grade) at EBWWTP Levee  
Crossing 54-inch SFM

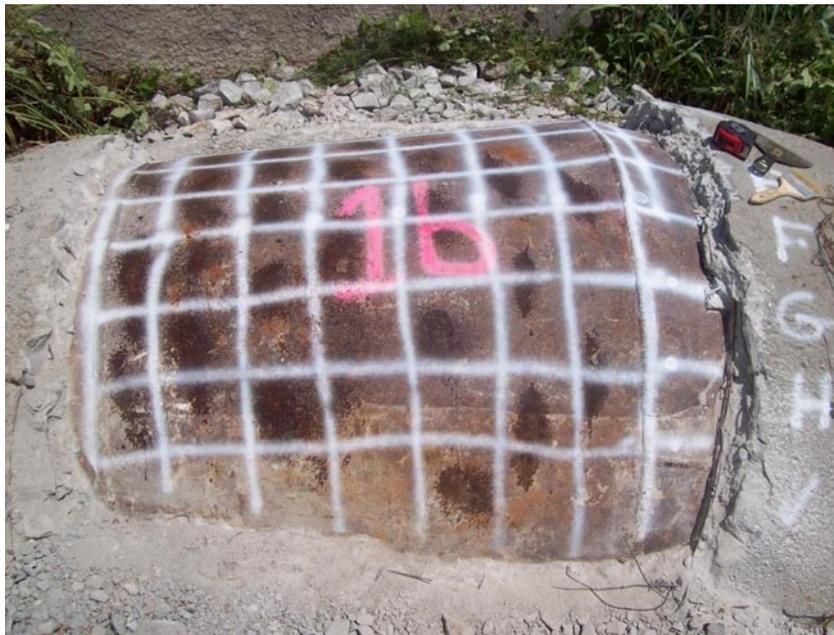
**Location 1B at East Bank WWTP**

Non Destructive Ultrasonic Testing (above grade) at EBWWTP Levee  
Crossing 54-inch SFM

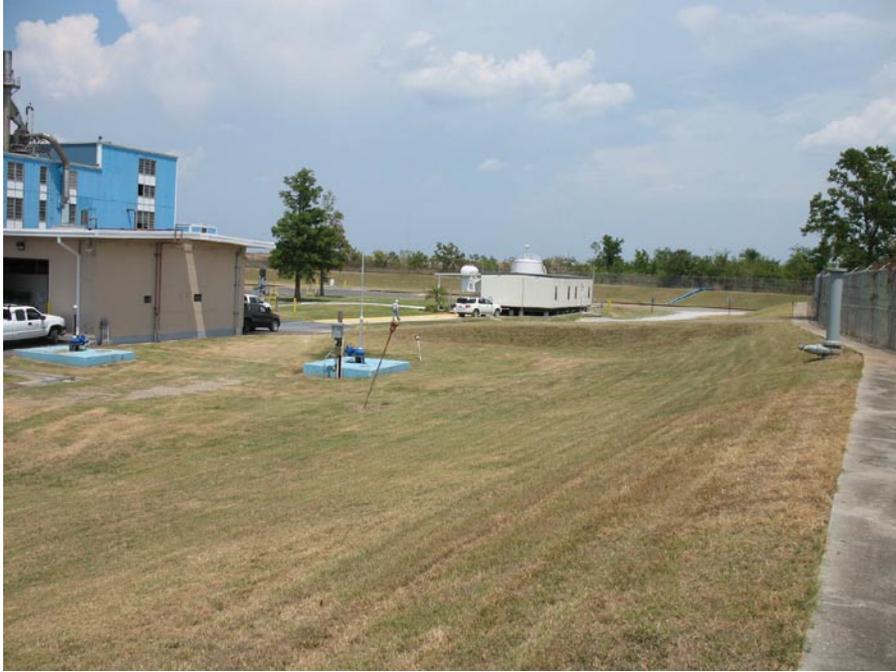
**Location 1C at East Bank WWTP**  
Coupon Retrieval (below grade) on 66-inch SFM

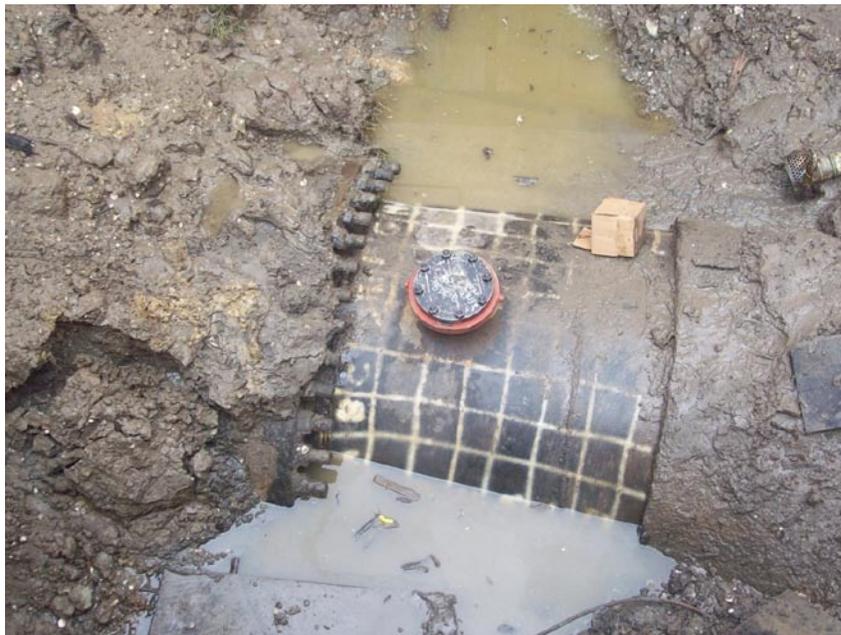
**Location 1C at East Bank WWTP**  
Coupon Retrieval (below grade) on 66-inch SFM

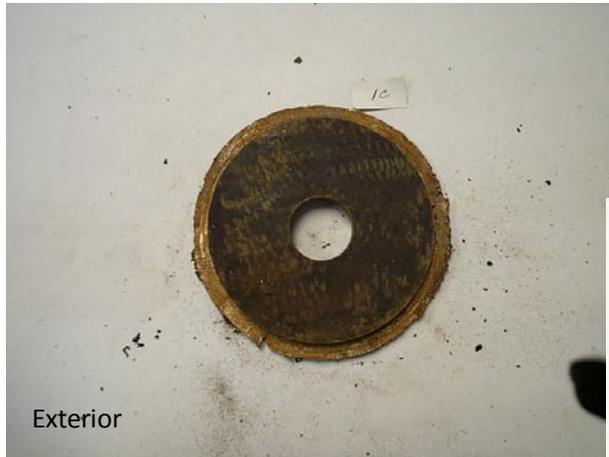
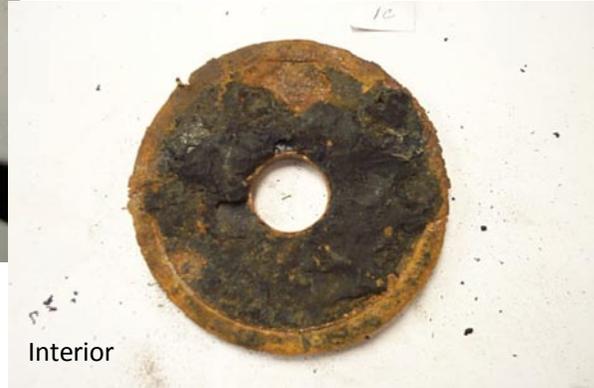
### Coupon 1C at East Bank WWTP

Coal tar coating 50% gone

Coupon Retrieval (below grade) on 66-inch SFM

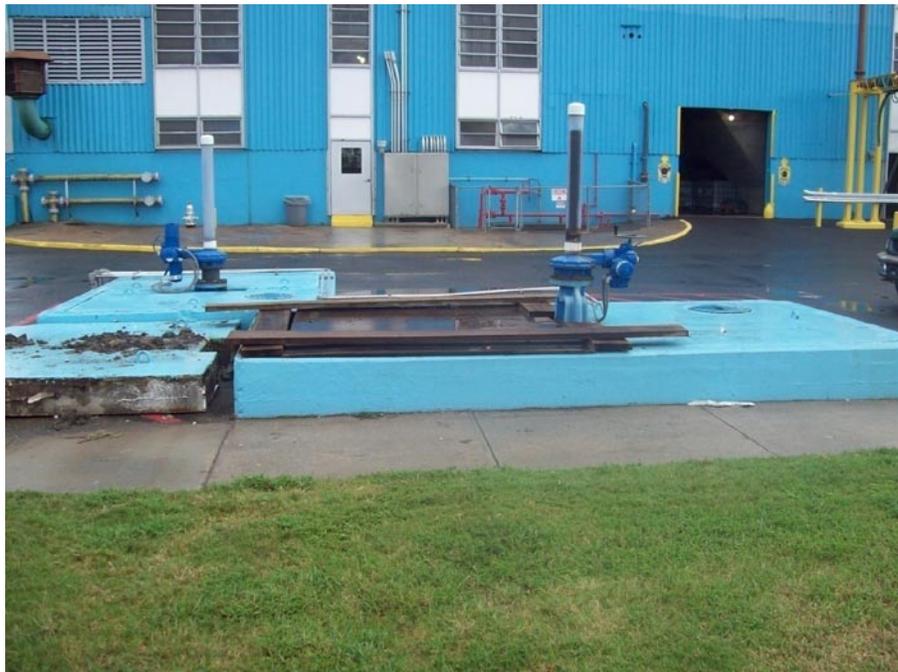
### Location 1D at East Bank WWTP

Coupon Retrieval (inside valve box) for 54-inch SFM

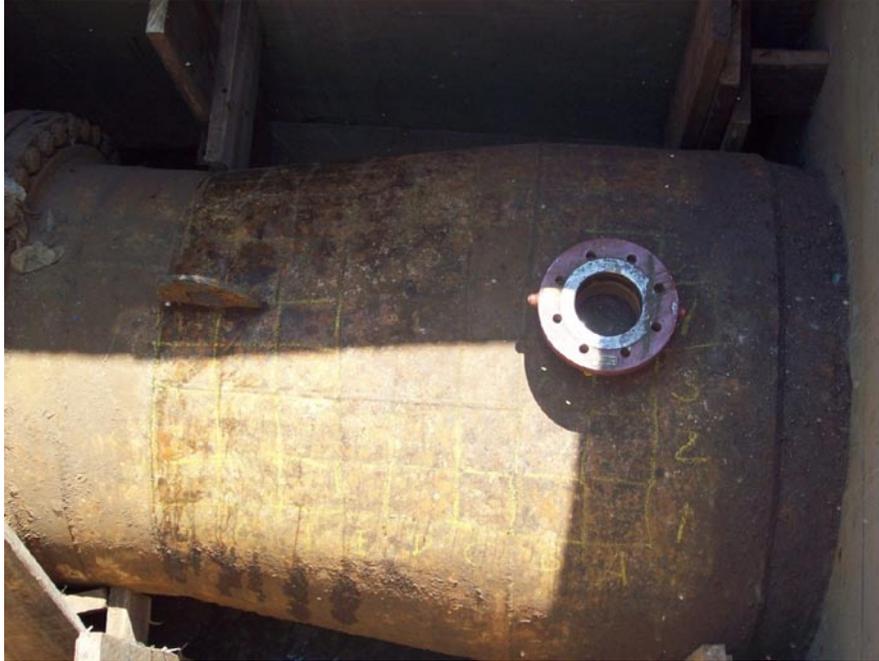
**Location 1D at East Bank WWTP**  
Coupon Retrieval (inside valve box) for 54-inch SFM

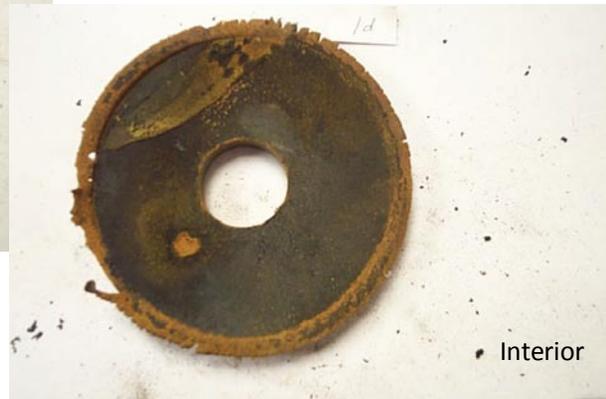
Interior

One pit 0.030" deep

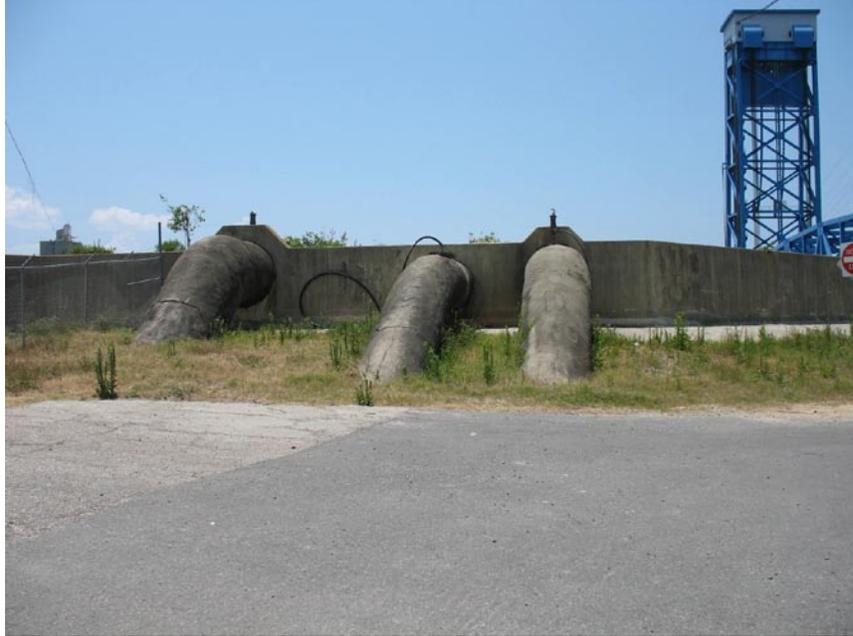
### Locations 2A and 2B East of the Industrial Canal

Non Destructive Testing Guided Wave (above grade) 66-inch and 54-inch SFMs.  
Water line between two SFMs.

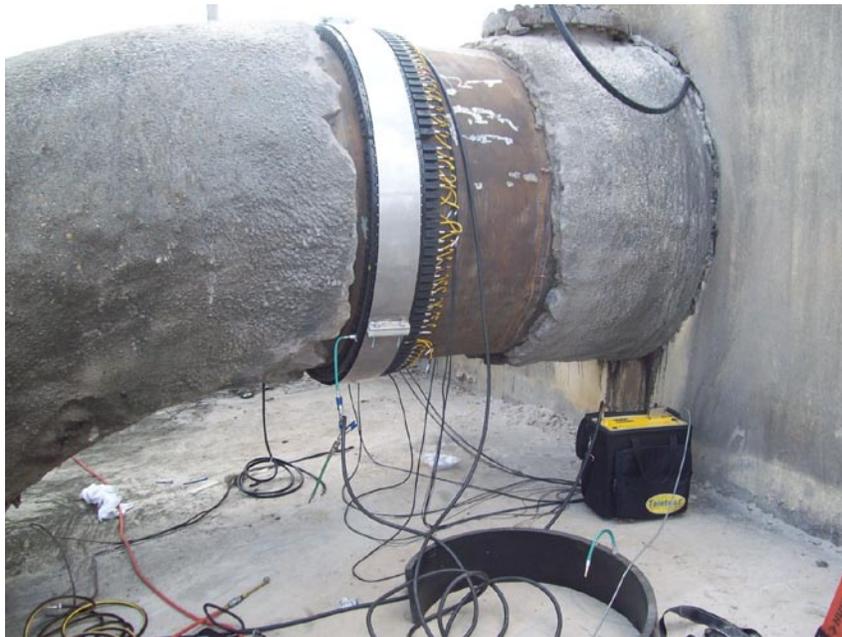
### Location 2B East of the Industrial Canal

Guided Wave (above grade) 54-inch SFMs

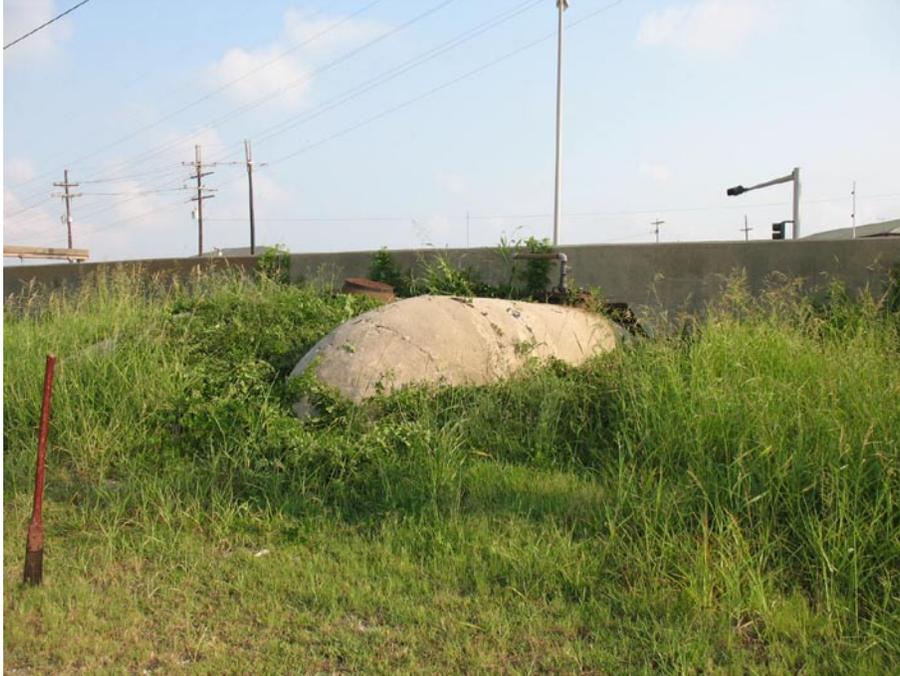
### Location 3A West of the Industrial Canal

Coupon Retrieval (above grade) 54-inch SFM

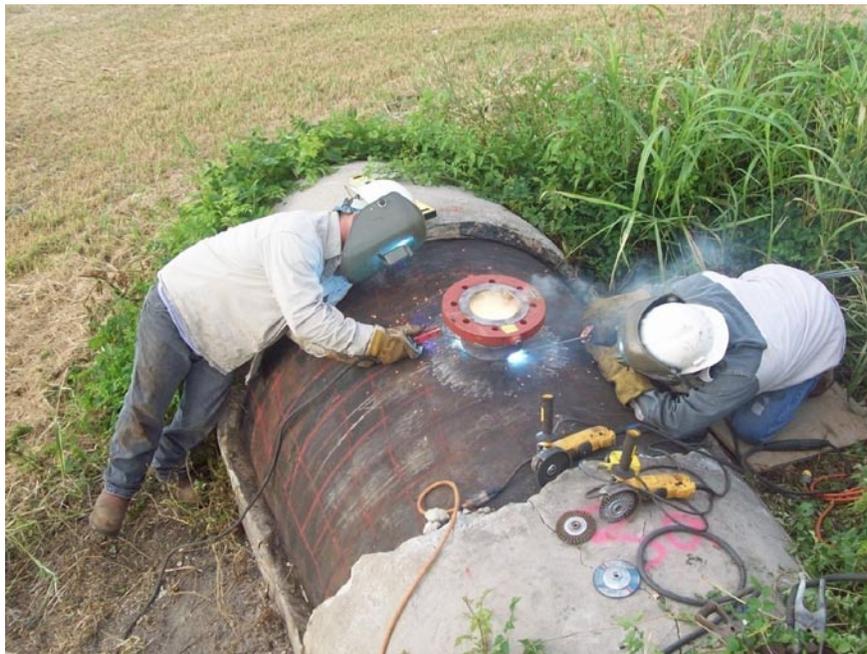
### Location 3A West of the Industrial Canal

Coupon Retrieval (above grade) 54-inch SFM

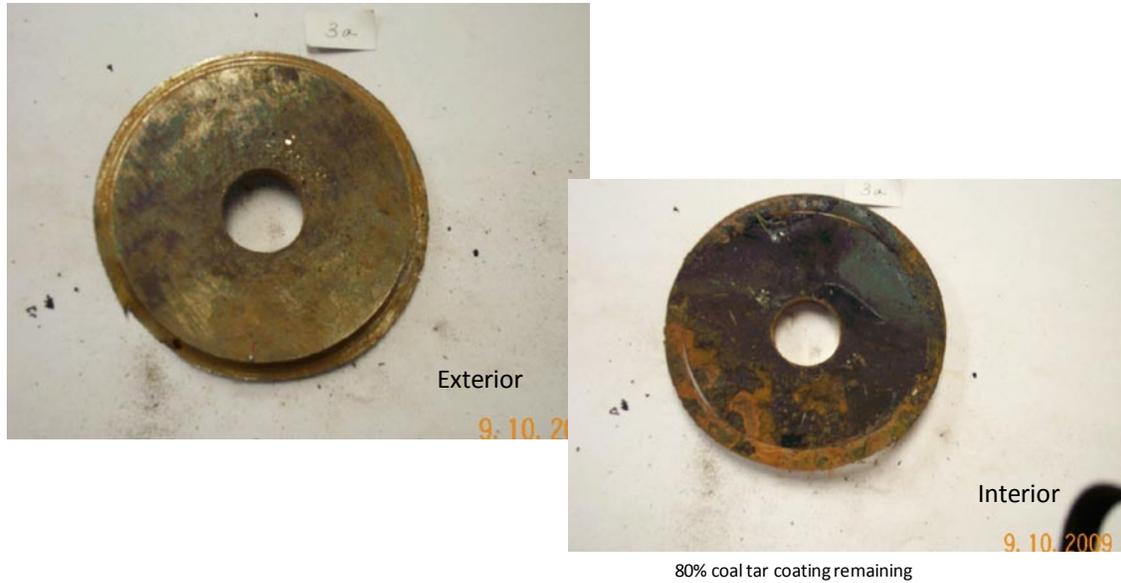
### Coupon 3A West of the Industrial Canal

Coupon Retrieval (above grade) 54-inch SFM

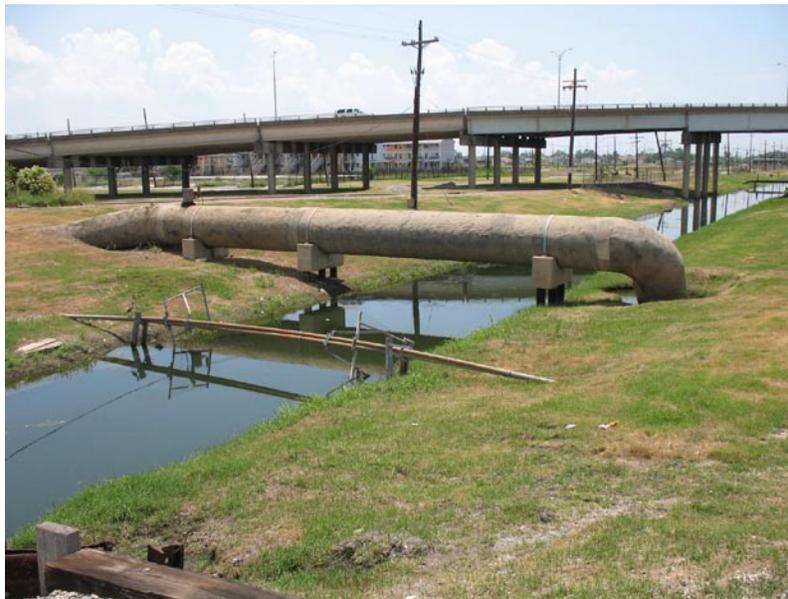
### Location 4A Florida Avenue Canal Crossing

Non Destructive Ultrasonic Testing (above grade) 72-inch SFM

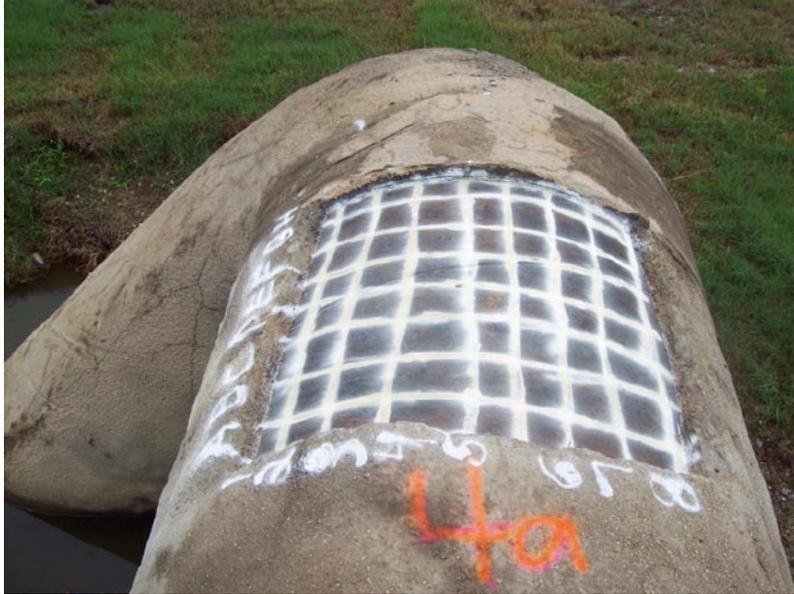
### Location 4A Florida Avenue Canal Crossing

Non Destructive Ultrasonic Testing (above grade) 72-inch SFM.

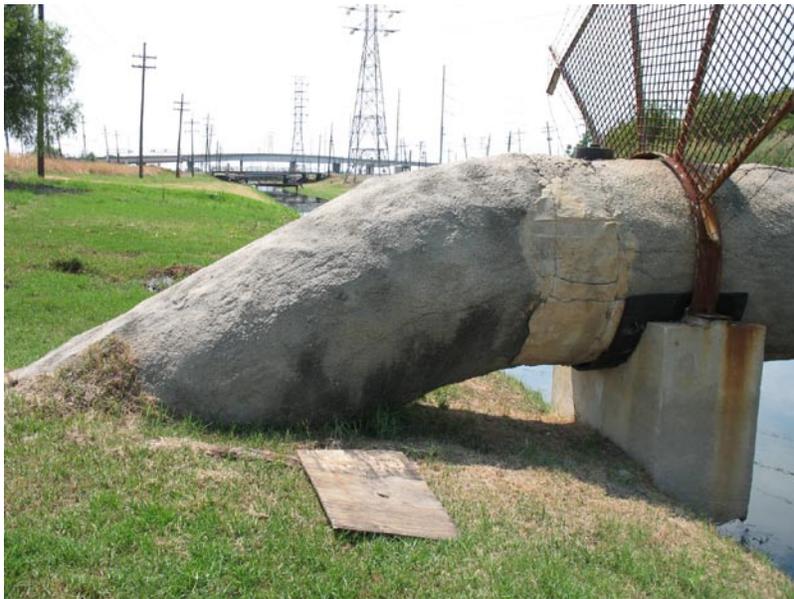
### Location 4B Florida Avenue Canal Crossing

Non Destructive Ultrasonic Testing (above grade) 54-inch SFM

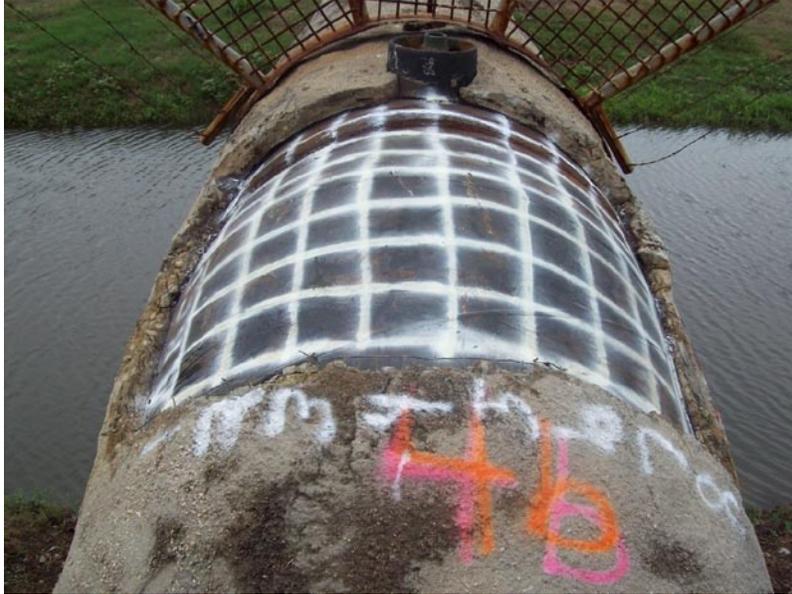
### Location 4B Florida Avenue Canal Crossing

Non Destructive Ultrasonic Testing (above grade) 54-inch SFM

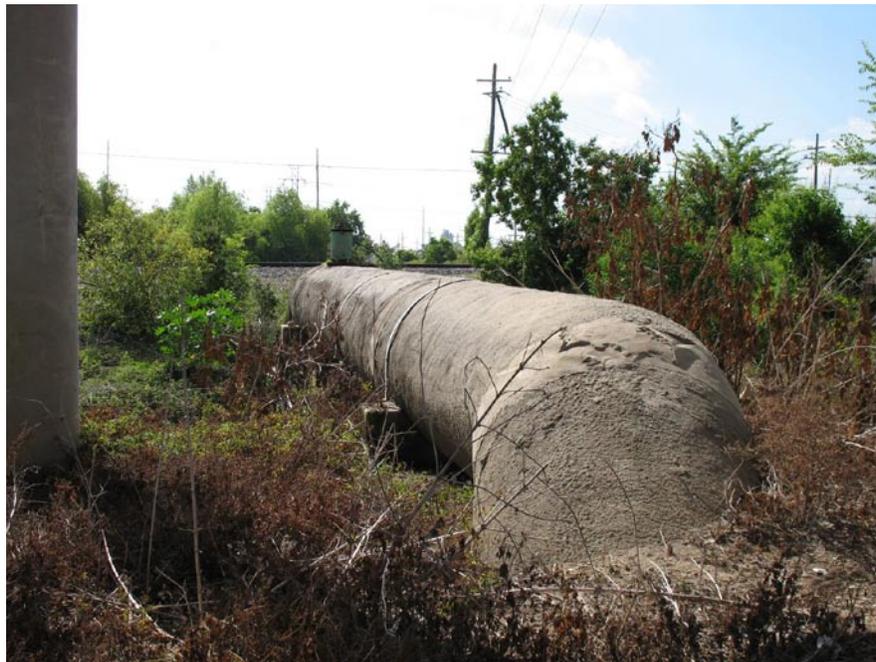
### Location 5A Peoples Ave near SPS D

Coupon Retrieval (above grade) 72-inch SFM

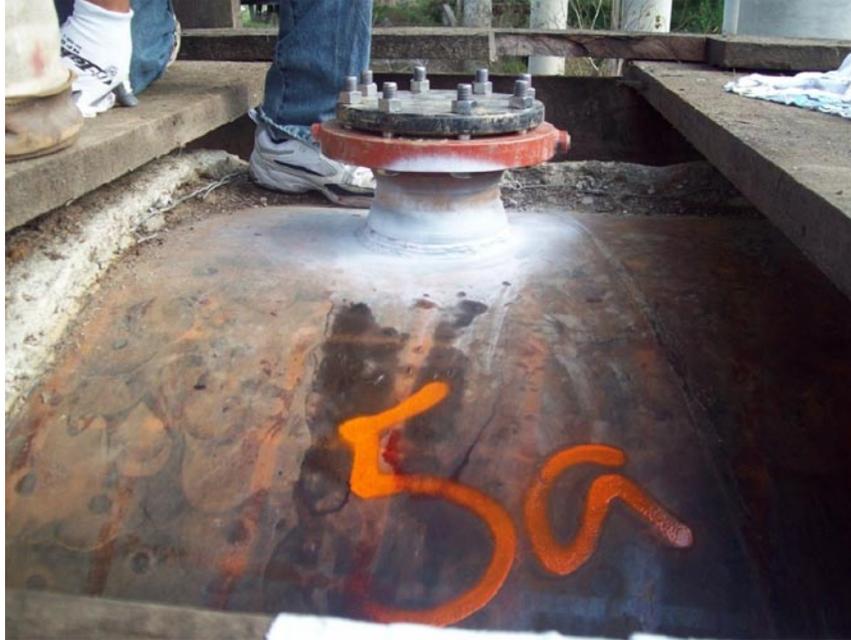
### Location 5A Peoples Avenue near SPS D

Coupon Retrieval (above grade) 72-inch SFM

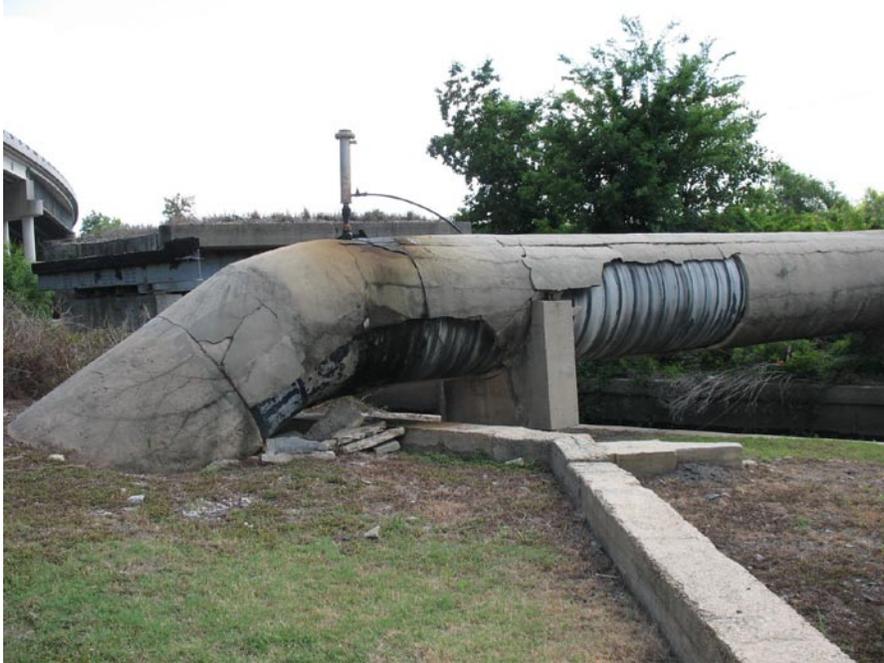
### Location 5B Peoples Avenue near SPS D

Coupon Retrieval (above grade) 60-inch SFM

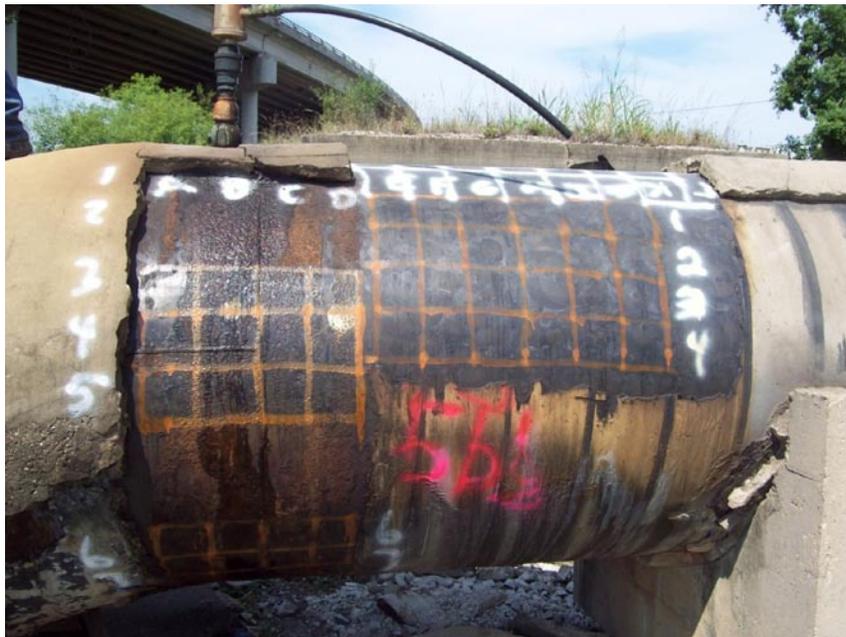
### Location 5B Peoples Avenue near SPS D

Coupon Retrieval (above grade) 60-inch SFM

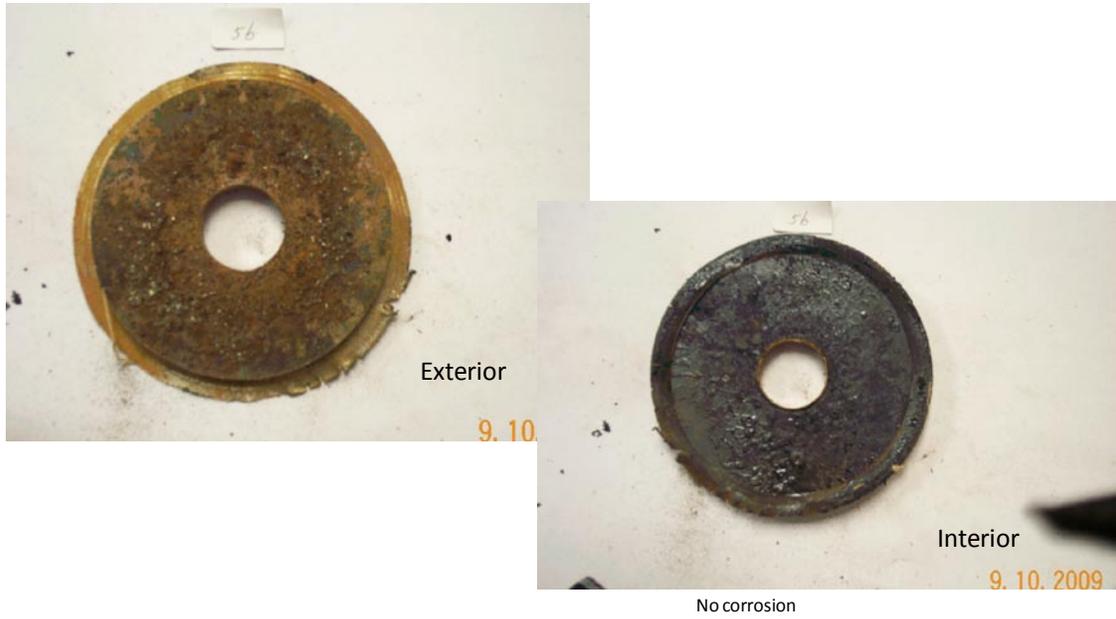
### Coupon 5B Peoples Avenue near SPS D

Coupon Retrieval (above grade) 60-inch SFM

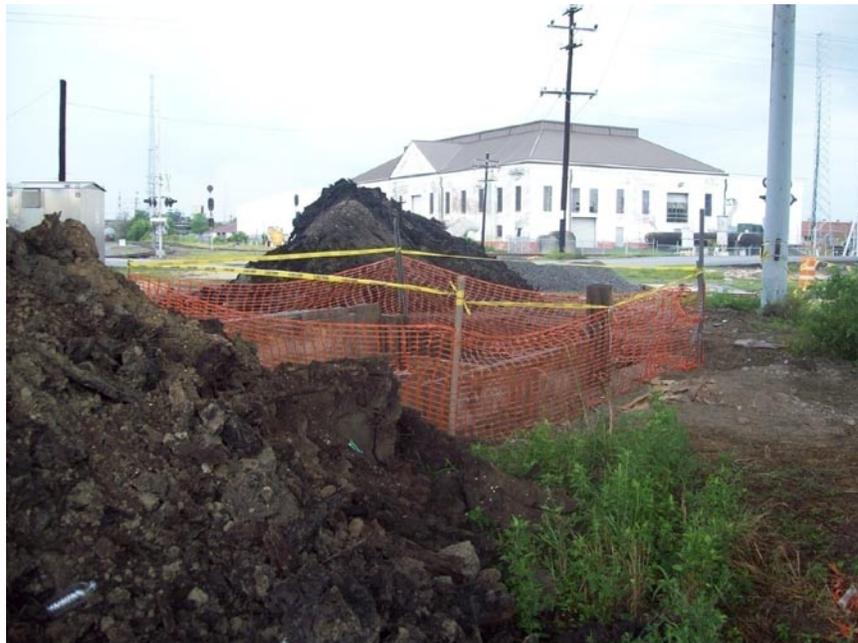
### Location 6A across Peoples Avenue from SPS D

Non Destructive Ultrasonic Testing 60-inch SFM

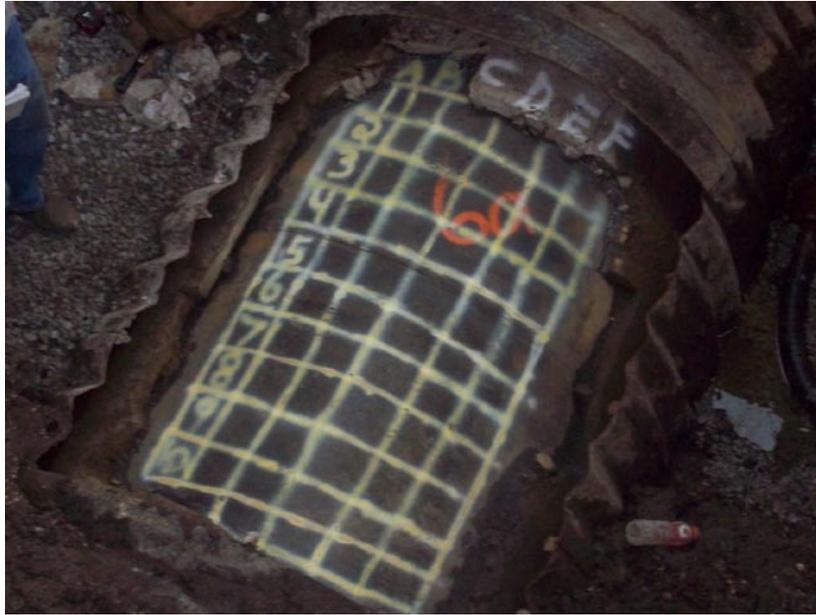
### **Location 6A across Peoples Avenue from SPS D**

Non Destructive Ultrasonic Testing 60-inch SFM

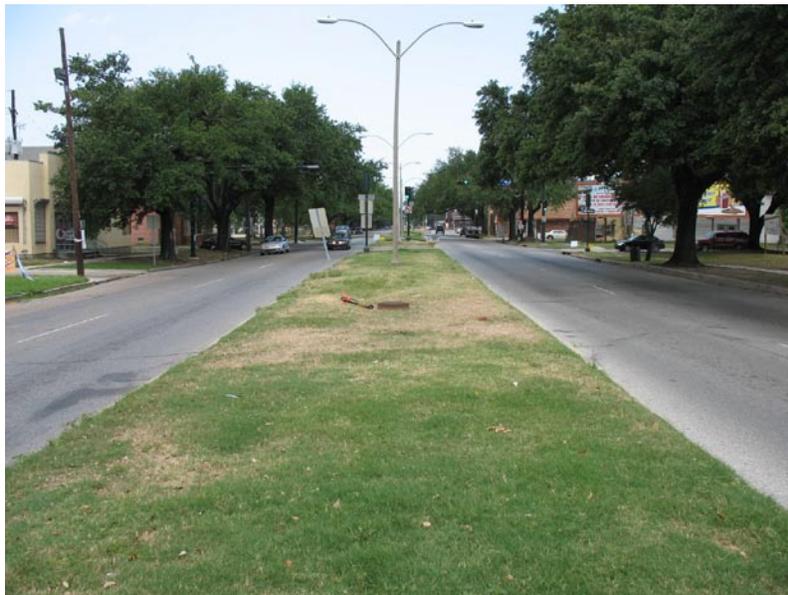
### **Location 7A St. Bernard Avenue Box Culvert Crossing**

Non Destructive Ultrasonic Testing (below grade) two 48-inch SFMs crossing the box culvert in the median. The SFMs are only 1 foot below grade and are cut into the top of the box culvert.

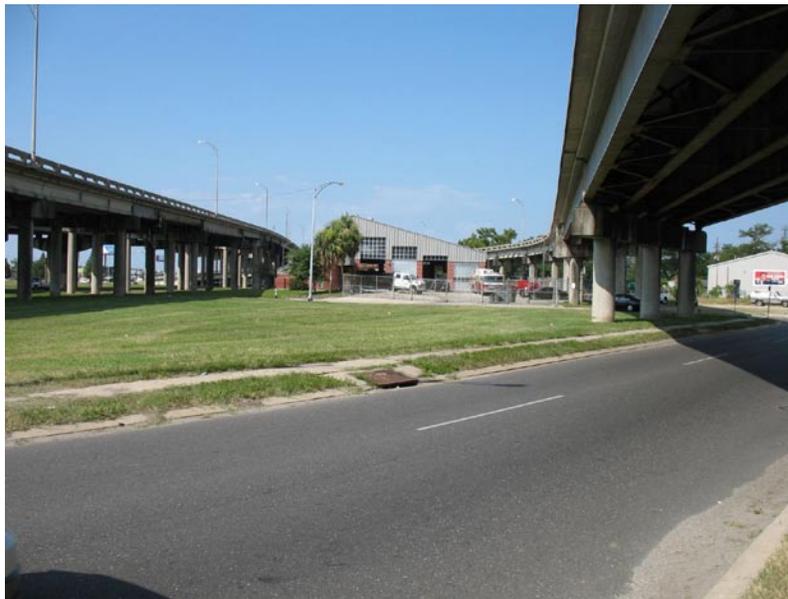
### **Location 8A behind Fire Station near I-10**

Non Destructive Ultrasonic Testing (below grade)

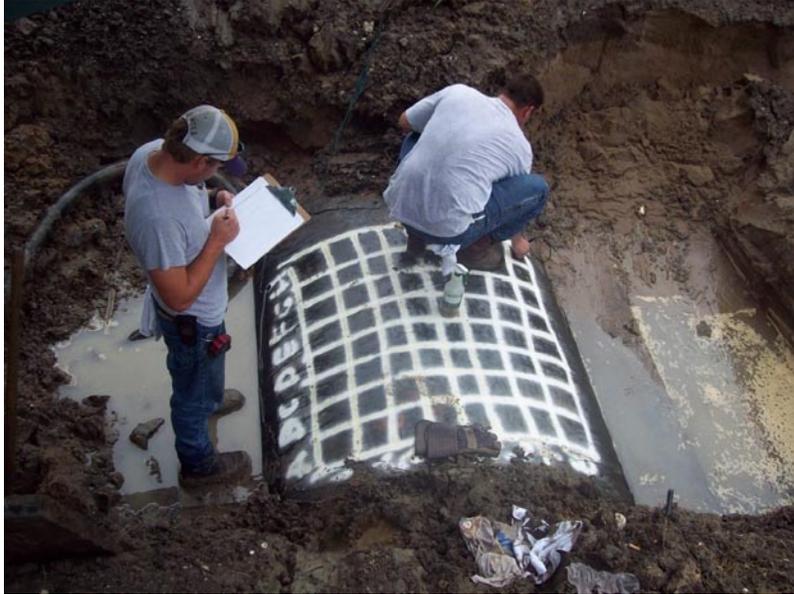
**Location 8A behind Fire Station near I-10**

Non Destructive Ultrasonic Testing (below grade)

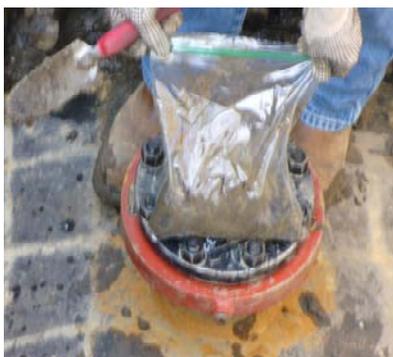
**ITEM:** Site 1-C

Visual inspection show that the coating condition is extremely poor. The coating has very little adhesion properties. It seems as if the coating has reached its life expectancy and is in the process of breaking down. During the visual inspection no pitting located and very minor surface corrosion present.

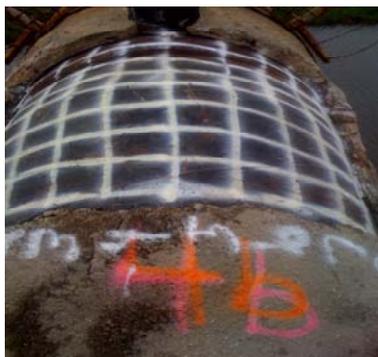
### ITEM: Site 4-B

Following the removal of the gunite, the coating appears to be in poor condition. The coating has very little adhesion properties. It seems as if the coating has reached its life expectancy and is in the process of breaking down. During the visual inspection no pitting located and very minor surface corrosion present.

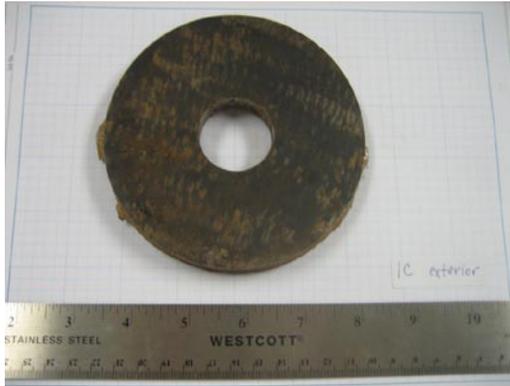
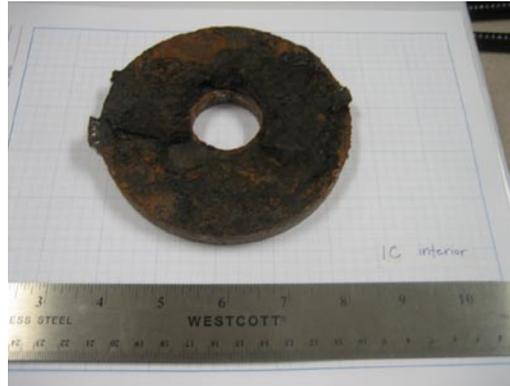
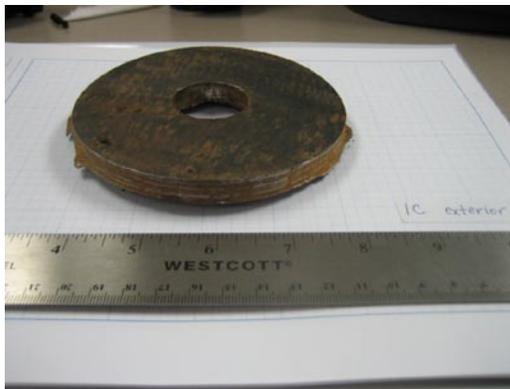
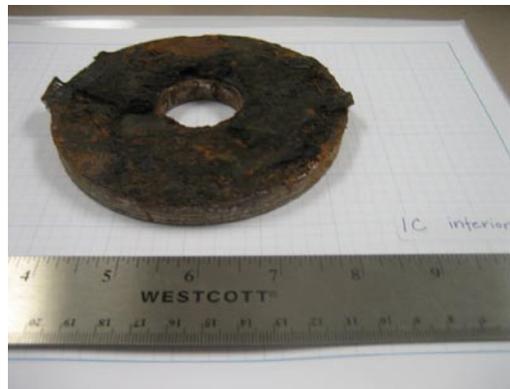
Coupon 1C 66" inside EBWWTP

- **1A-1-66-NDT AT EBSTP LEVEE-** No rejectionable findings were noted.
- **1B-1-54-NDT AT EBSTP LEVEE -** No rejectionable findings were noted.
- **1C-1-66-COUPON AT EBSTP -** There are 59 TML points with a calculated wall loss of 15% or greater, the highest being 24% at 7A-4.
- **1D-1-54-NDT COUPON AT EBSTP LEVEE-** No rejectionable findings were noted.

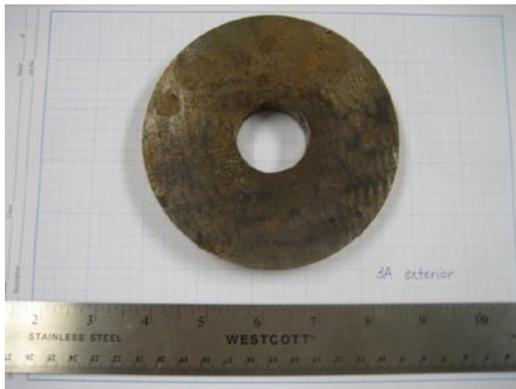
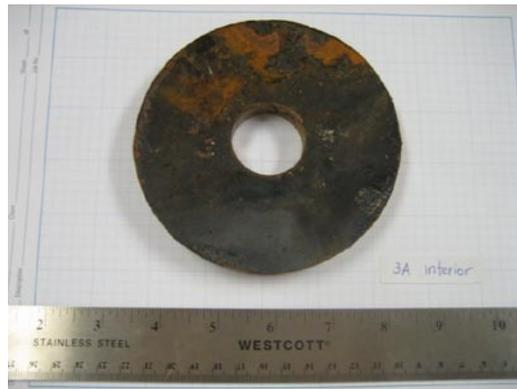
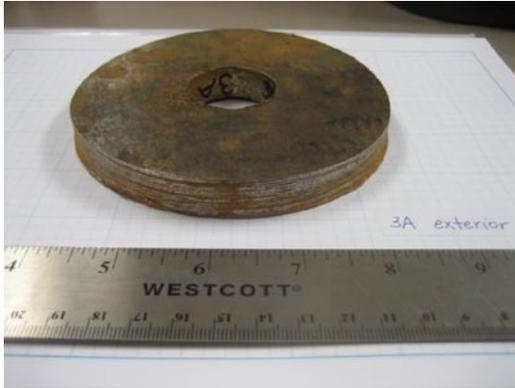
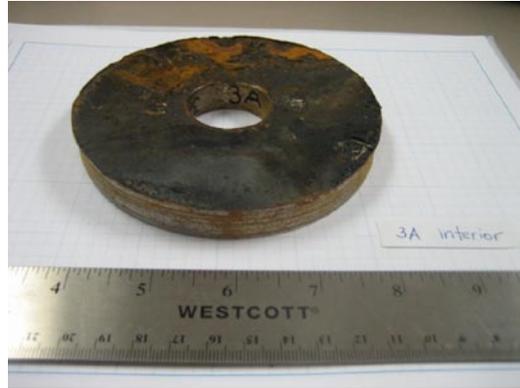
**Coupon 3A 54" West of Industrial Canal**

- **3A-3-54 COUPON AT W. B. IND. CANAL-** No rejectionable findings were noted.
- **4A-4-72-NDT AT FLORIDA AVENUE CANAL CROSSING-** No rejectionable findings were noted.
- **4B-4-54-NDT AT FLORIDA AVENUE CANAL CROSSING-** No rejectionable findings were noted.
- **5A-5-72-COUPON AT CROSSING OF PEOPLES AVENUE CANAL-** No rejectionable findings were noted.
- **5B-5-60 COUPON AT CROSSING OF PEOPLES AVENUE CANAL-**  
There areas of moderate to severe pitting, where readings were not taken due to the poor condition of the pipe.
- **6A-6-60-NDT AT YARD OF PUMP STATION D-**There are 12 TML points with a calculated wall loss of 17% or greater, the highest being 24% at 5B.2, 5B.5 and 5B.9.
- **7A1-7-48-NDT AT ST. BERNARD AVE.-** No rejectionable findings
- **7A2-7-48-NDT AT ST. BERNARD AVE.-** No rejectionable findings
- **8A-8-72-NDT AT FRENCHMEN ST-** No rejectionable findings

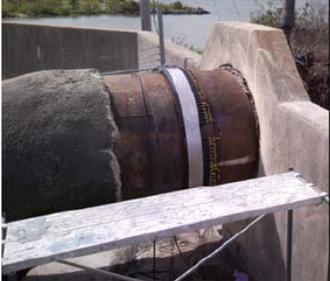
Pipe ID	Diameter	Datum Description	Comments	Photograph
66" Sewer Force Main	66in	Levy wall penetration 2 ft. 4 in. behind tool	<p>A reasonable signal to noise ratio was obtained in the backwards directions heading west towards the canal. Several weld-like indications were identified and should be confirmed. Two Category 1 indications were noted in the backwards direction.</p> <p>The signal quality was reduced in the forwards direction as the tool was placed directly against a steel band. Therefore, the inspection confidence is decreased. Several weld-like indications were identified in this direction and should be confirmed.</p>

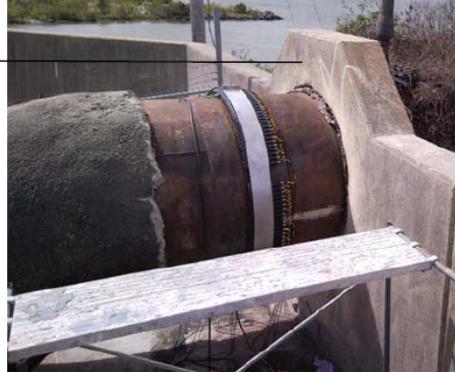
Datum is face of wall penetration 2 ft. 4" behind tool

Pipe ID	Diameter	Datum Description	Comments
66" Sewer Force Main	66in	Levy wall penetration 2 ft. 4 in. behind tool	Several weld-like indications were noted and should be confirmed. Several Category 1 indications were also noted.

Distance relative to Datum	Indication Description	Comments
-17.7 ft	Weld	Unable to confirm via supplied drawings or visually. Should be verified.
-12.4 ft	Cat 1.	
-10.5 ft	Weld	Unable to confirm via supplied drawings. Should be verified.
-5.4 ft	Cat 1.	
-2.8 ft	Branch	
-1.1 ft	Weld	Unable to confirm via supplied drawings or visually. Should be verified.
7.2 ft	Weld	Unable to confirm via supplied drawings or visually. Should be verified.
10.1 ft	See info	Strong axisymmetric Cat. 2 amplitude response. Could be from a weld. This indication could also be from a reverberating signal caused by the steel band in front of the tool.
12.6 ft	See info	Strong axisymmetric Cat. 1 amplitude response. Could be from a weld. This indication could also be from a reverberating signal caused by the steel band in front of the tool.
18.3 ft	Weld	Unable to confirm via supplied drawings. Should be verified.

A reasonable signal to noise ratio was obtained in the backwards directions heading west towards the canal. Several weld-like indications were identified and should be confirmed. Two Category 1 indications were noted in the backwards direction.

The signal quality was reduced in the forwards direction as the tool was placed directly against a steel band. Therefore, the inspection confidence is decreased. Several weld-like indications were identified in this direction and should be confirmed. Also noted were Category 1 and 2 amplitude responses which were axisymmetric in nature implying they may be from welds or some other axisymmetric reflector (i.e., an axisymmetric coating disbond). These indications may also have been caused by some of the energy reverberating in the steel band directly in front of the tool.

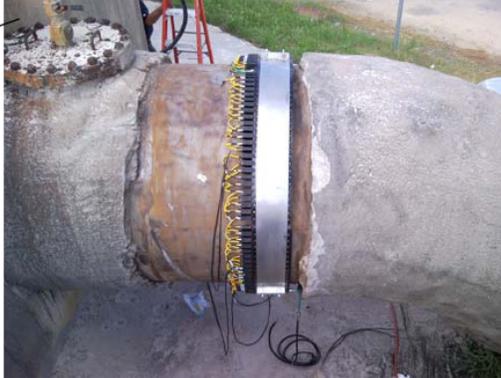
Datum is face of wall penetration 5 behind tool

Pipe ID	Diameter	Datum Description	Comments
54" Sewer Force Main	54in	Levy wall penetration 5ft behind tool	Several weld-like indications were noted and should be confirmed. Several Category 1 indications were also noted.

The signal to noise ratio obtained on this pipe was not as good as that obtained on the 66" pipe. Only half of the possible transducer modules were used due to complications with the electronics driving hardware which most-likely caused a loss of penetration power and the decreased signal to noise ratio. Several weld-like indications were identified in the backwards direction towards the canal and should be confirmed. Two Category 1 indications were also noted in the backwards direction. The quality of the scan in the forwards direction was very poor as the tool was placed directly against the tar coating. Two weld-like indications were noted in the forwards direction and should be confirmed. The quality of the scan in this direction was so poor that there is very low confidence that flaw indications less than 20% of the pipe's cross sectional area could even be detected.
